In-Depth Inspection Report for

City of Margate

2MG CONCRETE GST - City of Margate WTP 92'D x 40'H

Inspection Date: 4/1/25

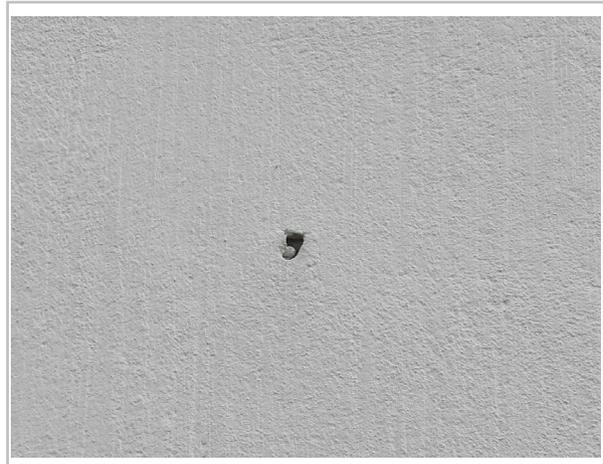
Small Pop-out / Spall (Wall)

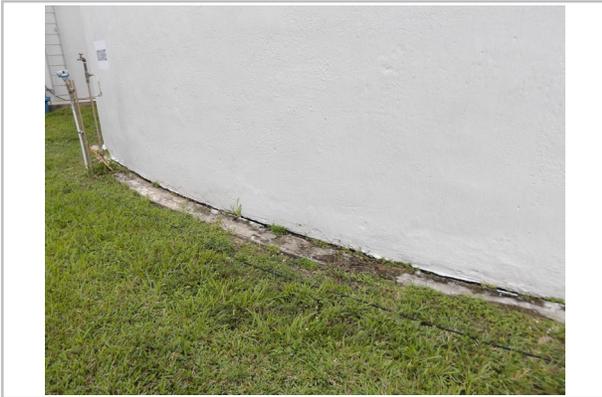
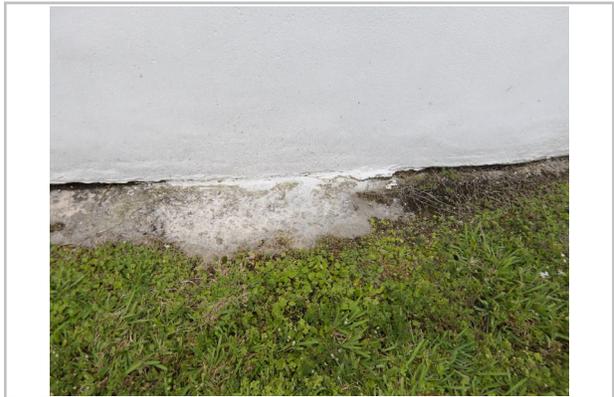
Foundation Condition

- * Foundation buried w/ portions exposed *
- Ratings apply to exposed portions of foundation
- Moderate erosion unlocalized throughout areas of exposed foundation
- Minor to moderate undermining present where foundation is exposed

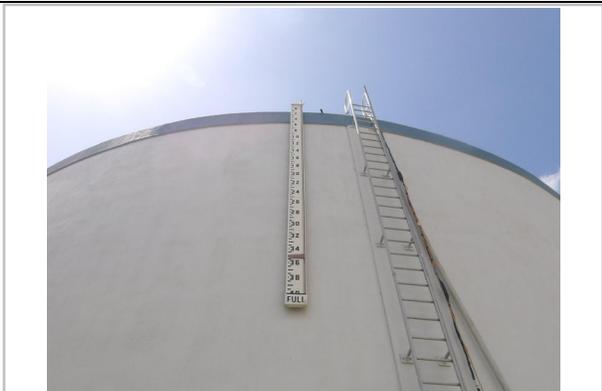
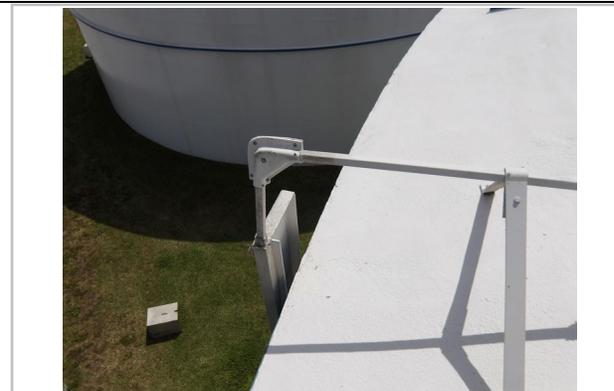
Float Level Indicator Condition

- Minor weather staining present
- Minor d-lamination unlocalized throughout, exposing fiberglass
- Oxidation & corrosion localized throughout hardware

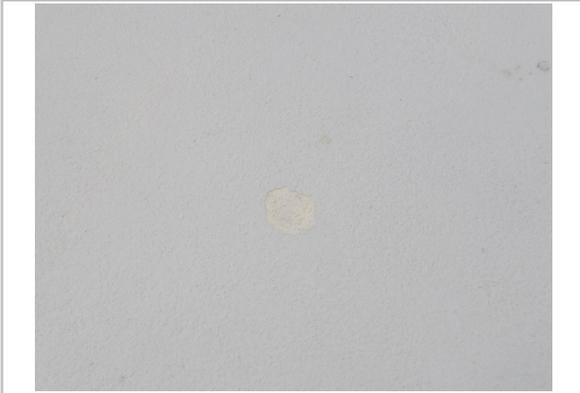
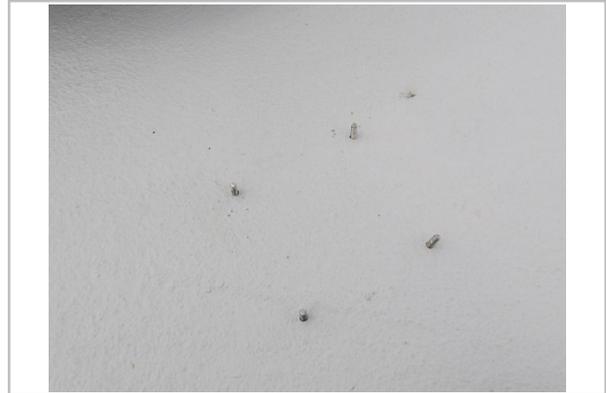
Roof Condition

- Minor d-lamination localized in areas of opened blisters
- Minor to moderate small to medium blistering unlocalized throughout
- Minor sags & runs noted
- Abandoned hardware present

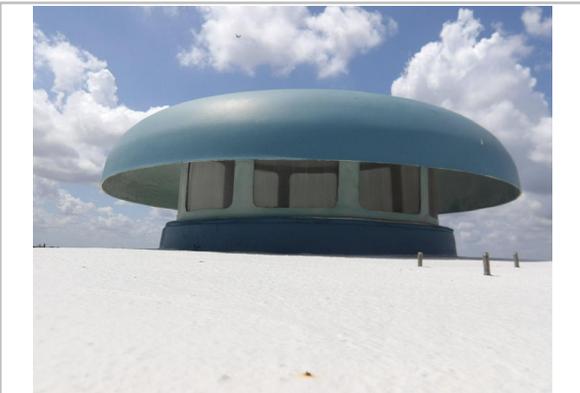
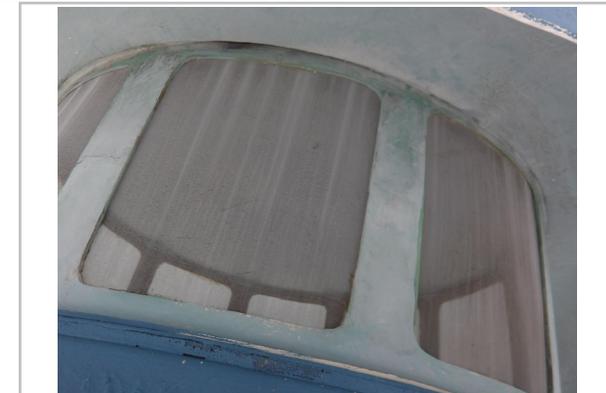
Vent Condition

- Minor d-lamination noted throughout protective coating
- Mushroom cap design w/ an approx. 6" concrete rise
- Minor weather staining present

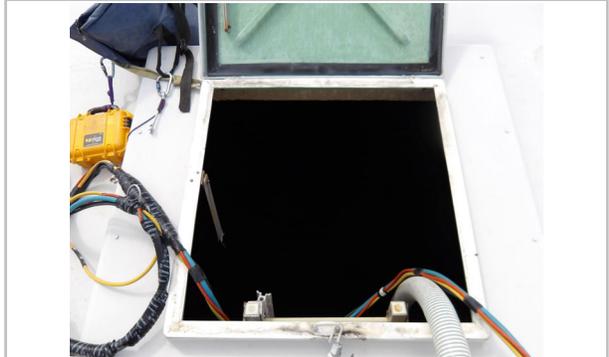
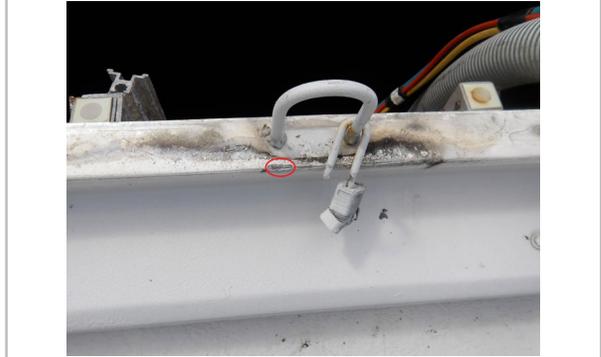
Access Hatch Condition

Corrosion Ratings(%):
 None: N/A
 Uniform Surface Corrosion: Approx. < 2%
 Crevice Corrosion: N/A
 Rust Noduling/Pitting: N/A Depth: N/A
 Scaling: N/A
 Other Corrosion(specify): N/A
 Oxidation: Approx. < 3%
Seams/Welds Condition: Good
 Insects, Dirt or Debris Present Under Hatch? Y N
 Any irregularities or structural deficiencies? Y N
 Description: Material Loss & Broken Hinge System
Overall Condition: Fair
Additional Notes:
 - Minor gasket deterioration present
 - Internal hinge system is broken
 - Oxidation & corrosion localized throughout hardware
 - Minor material loss localized around hatch rim near lock

3. Exterior:
 - 3.1. Walls - Repair/ seal cracking (Minor); Patch/ spot repair areas of concrete deterioration (Minor)
 - 3.2. Access Ladder - Treat areas of corrosion (Minor); Replace corroding hardware (as needed); Ensure access ladder is in compliance with OSHA regulations: 1910.29(b)(13)(i) (No swing gate)
 - 3.3. Foundation - Rehab areas of erosion/ undermining (Mod)
 - 3.4. Roof - Touch-up / spot repair areas of coating failure (Minor); Remove abandoned hardware
 - 3.5. Access Hatch - Replace broken internal hinge system; Replace corroding hardware (as needed); Seal areas of cracking (Minor); Rehab areas of material loss localized around hatch rim and touch up coating

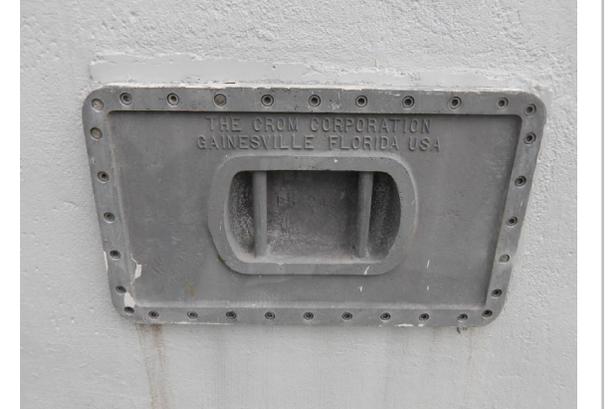
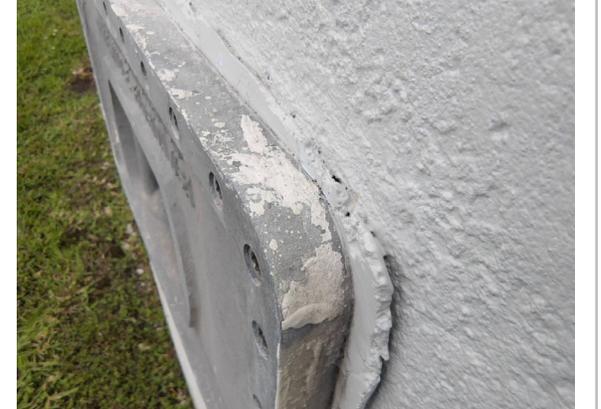
Manway Condition

Corrosion Ratings(%):
 None: N/A
 Uniform Surface Corrosion: N/A
 Crevice Corrosion: N/A
 Rust Noduling/Pitting: N/A Depth: N/A
 Scaling: N/A
 Other Corrosion(specify): Galv: Approx. < 4%
 Oxidation: Approx. < 5%
Overall Condition: Good
Additional Notes:
 - Galvanized steel construction
 - Gasket material painted over
 - Minor weather staining noted

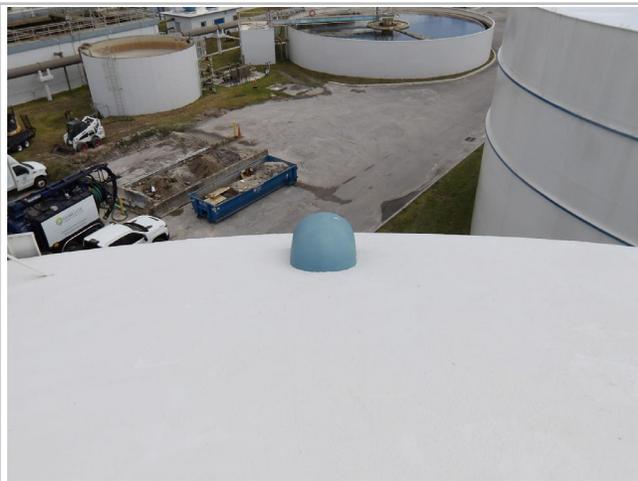
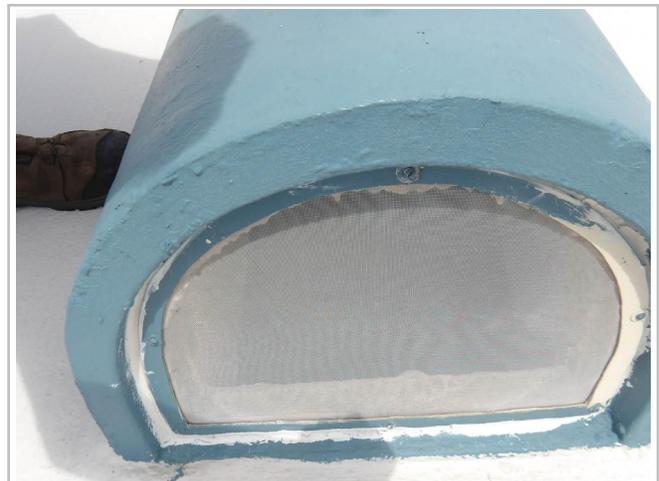
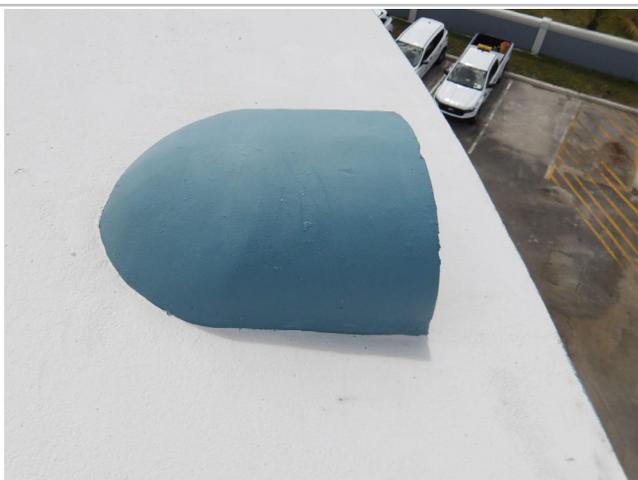
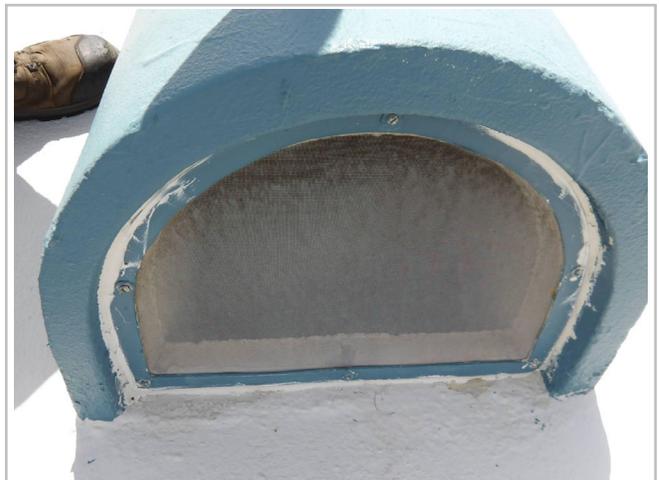
Overflow Structure Condition

- Minor d-lamination noted throughout protective coating
- Minor sags & runs present

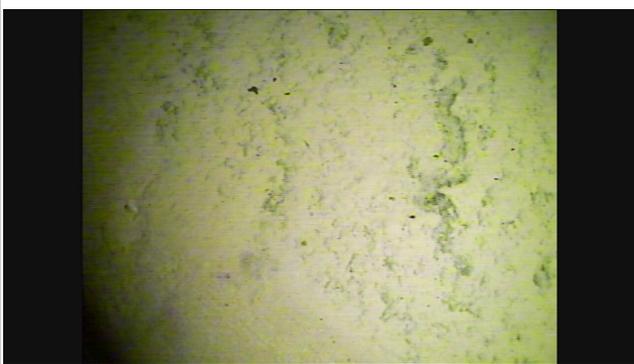
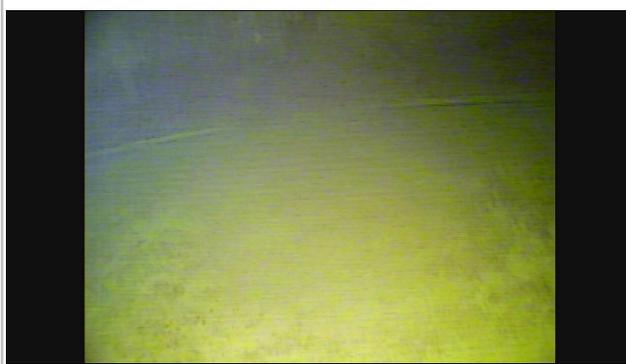
Floor Condition

- Minimal discrepancies noted throughout
- General concrete unevenness present throughout
- Minor sediment staining noted throughout
- Minor hairline / shrinkage cracking unlocalized throughout
- D-alloyed metal has settled into the floor
- Minor exposed aggregate unlocalized throughout
- Floor to wall expansion joint in good to fair condition

- 4.2. Ladder - Treat areas of corrosion (Minor); Replace corroding hardware (as needed)
 - 4.3. Floor - Rehab floor to wall expansion joints (Good to Fair); Repair/ seal areas of cracking (Minor); Rehab areas of concrete deterioration (Minor) and touch up areas of coating failure (Minor)

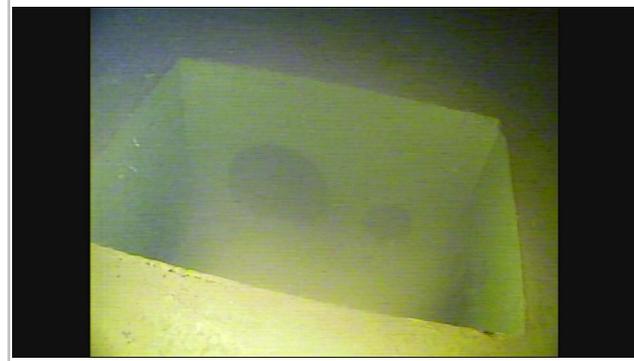
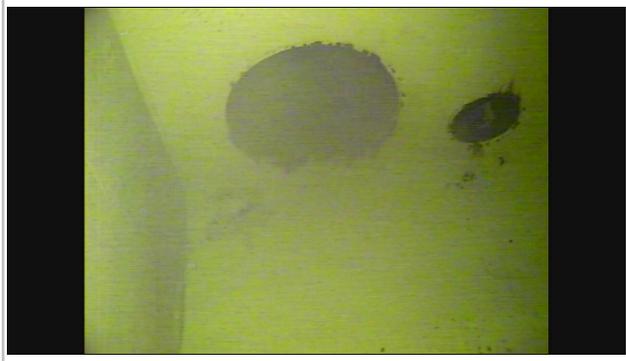
Drain Condition

- Drain sits in a sump area next to the inlet (right)
- Oxidation, corrosion, & rust noduling unlocalized throughout
- Unable to observe the inside of the plumbing
- Minor to moderate corrosive staining present

- 4.4. Drain - Treat areas of corrosion/ rust noduling (Minor/ Mod); Apply protective coating
 - 4.5. Wall - Repair/ seal areas of cracking (Mod); Rehab areas of concrete deterioration (Minor abrasion) and apply protective coating

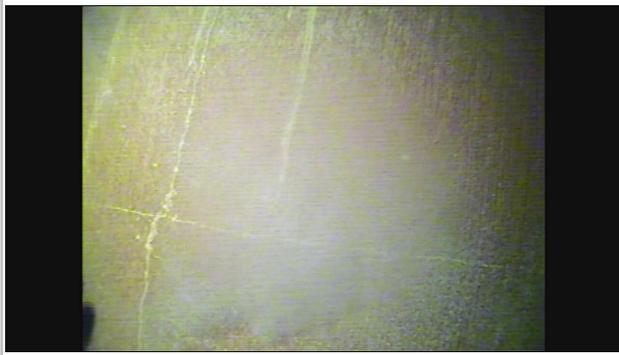
Wall Condition

- Minor to moderate hairline / shrinkage cracking present throughout
- Minor abrasion unlocalized throughout
- Moderate sediment staining throughout
- Moderate mineral growth unlocalized throughout

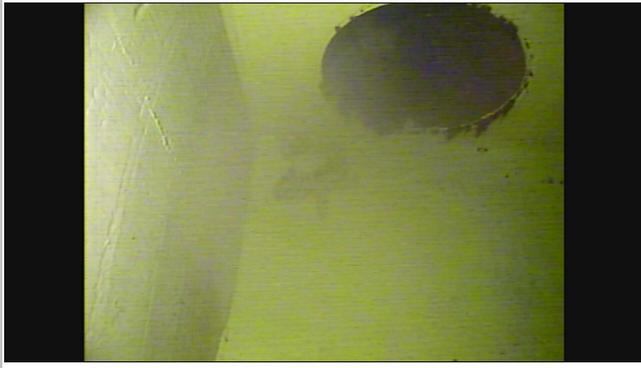
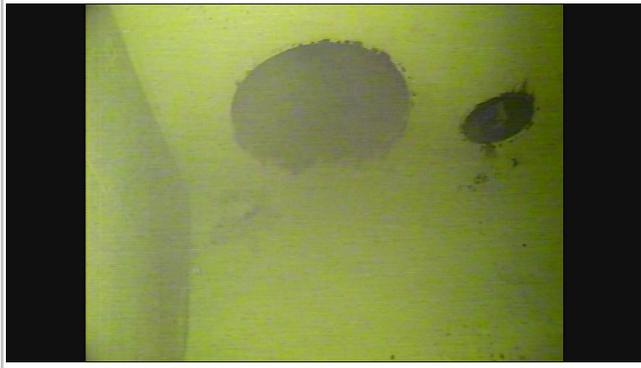
Inlet Condition

Corrosion Ratings(%):
 None: N/A
 Uniform Surface Corrosion: Approx. < 20%
 Crevice Corrosion: N/A
 Rust Noduling/Pitting: Approx. < 10% Depth: 1/16"
 Scaling: N/A
 Other Corrosion(specify): N/A
 Oxidation: Approx. < 25%
Overall Condition: Good to Fair
Additional Notes:
 - Inlet rests in a sump area next to the drain (left)
 - Oxidation, corrosion, & rust noduling unlocalized throughout
 - Minor to moderate corrosive staining present
 - Unable to observe the inside of the plumbing

- 4.6. Inlet - Treat areas of corrosion/ rust noduling (Mod); Apply protective coating
 - 4.7. Outlet - Treat areas of corrosion/ rust noduling (Minor/ Mod); Apply protective coating

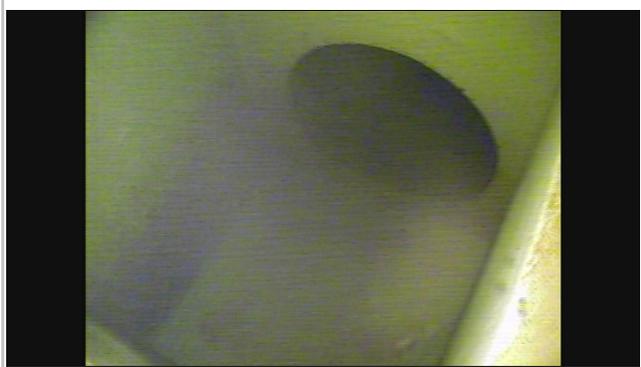
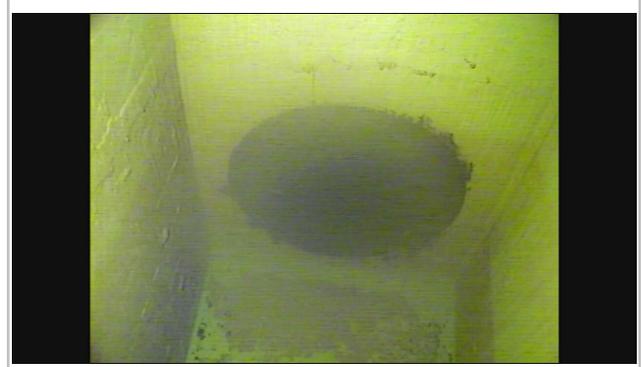
Outlet Condition

Corrosion Ratings(%):
 None: N/A
 Uniform Surface Corrosion: Approx. < 15%
 Crevice Corrosion: N/A
 Rust Noduling/Pitting: Approx. < 8% Depth: 1/16"
 Scaling: N/A
 Other Corrosion(specify): N/A
 Oxidation: Approx. < 20%
Overall Condition: Good to Fair
Additional Notes:
 - Outlet rests in a sump area
 - Oxidation, corrosion, & rust noduling unlocalized throughout
 - Minor to moderate corrosive staining present
 - Unable to observe the inside of the plumbing due to safety concerns

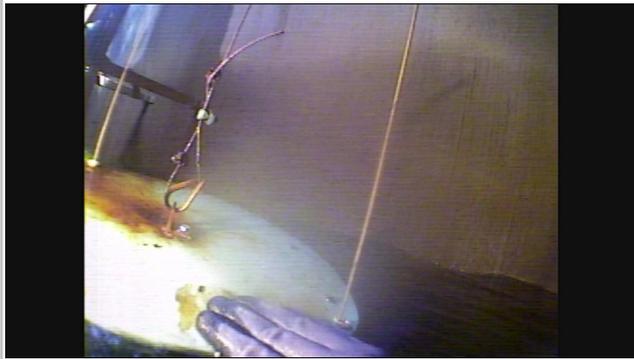
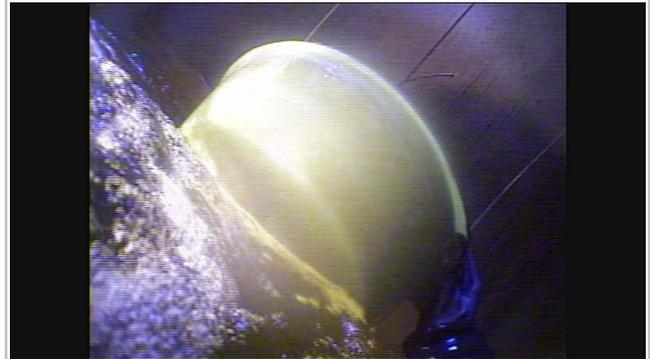
Float Condition

Corrosion Ratings(%):
 None: N/A
 Uniform Surface Corrosion: Approx. < 4%
 Crevice Corrosion: N/A
 Rust Noduling/Pitting: Approx. < 2% Depth: 1/16"
 Scaling: Approx. < 1%
 Other Corrosion(specify): N/A
 Oxidation: Approx. < 5%
Overall Condition: Fair to Poor
Additional Notes:
 - Center cable not attached properly, cable corroding & loose
 - Oxidation, corrosion, rust noduling, & scaling localized on hardware
 - Fiberglass float w/ corrosive & sediment staining present
 - Guide wires have some give to them

- 4.8. FLI - Replace corroding/ loose cables and adjust; Replace corroding hardware (as needed); Clean and reapply coating
 - 4.9. Overflow - Rehab areas of concrete deterioration (Minor pop-outs/ bug-holing/ spalling) and touch up areas of failing protective coating

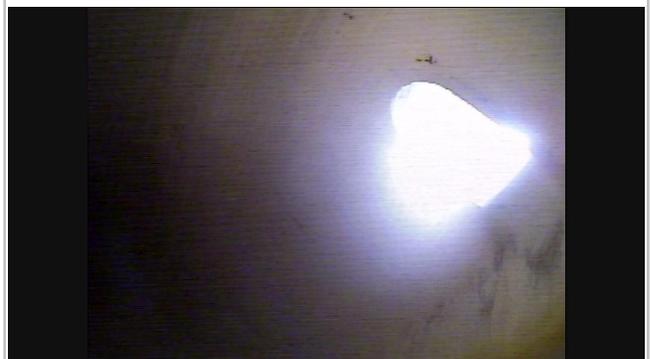
Overflow Condition

Corrosion Ratings(%):
 None: N/A
 Uniform Surface Corrosion: N/A
 Crevice Corrosion: N/A
 Rust Noduling/Pitting: N/A Depth: N/A
 Scaling: N/A
 Other Corrosion(specify): N/A
 Oxidation: N/A
Overall Condition: Good to Fair
Additional Notes:
 - Tank equipped w/ four(4) frog eye overflows
 - Minor bug-holing to small pop-outs / spalling unlocalized throughout
 - Minor moisture staining noted

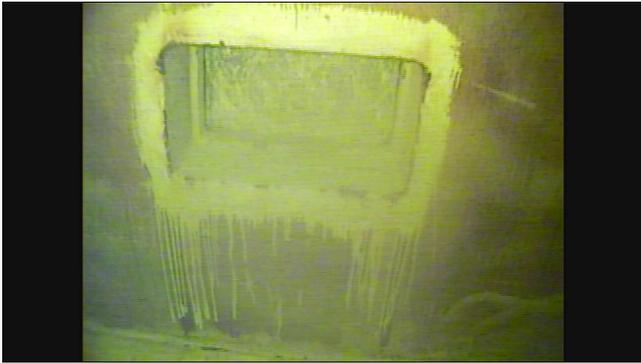
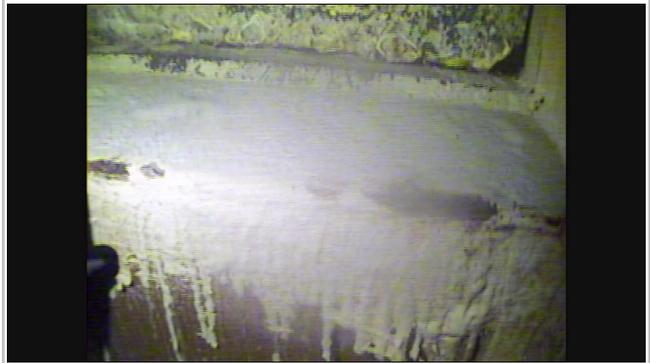
Manway Condition

- Galvanized steel manway lid w/ a stainless steel insert
- Oxidation, corrosion, & rust noduling unlocalized throughout insert
- Moderate to heavy galvanic corrosion & rust noduling noted on manway
- Moderate/ Heavy gasket deterioration present
- Minor d-lamination & small to medium blistering noted

Gasket Condition: Poor

- 4.10. Manway - Replace deteriorating gasket (Mod/ Heavy); Treat areas of corrosion (Mod/ Heavy); Rehab/ replace failing protective coating (Mod)

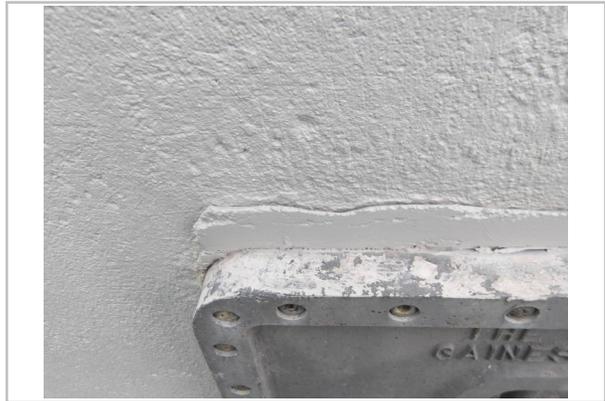
Painted Gasket
