In-Depth Inspection Report for

City of Margate

2MG GST

Coral Gate WTP

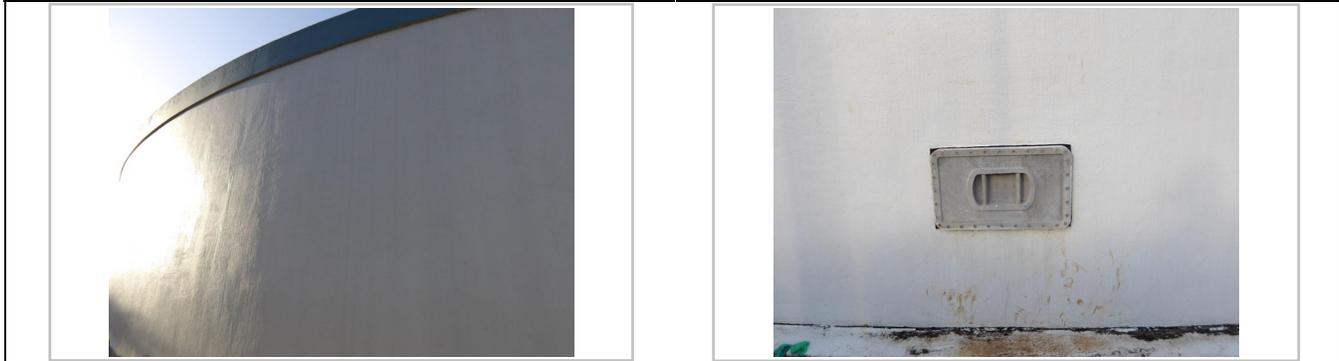
Wall Panel Condition

<p>Concrete / Coating Ratings: Signs of Leaking? Y <input checked="" type="radio"/> N <input checked="" type="radio"/> Coating Present? Y <input checked="" type="radio"/> N <input checked="" type="radio"/> <input type="checkbox"/> De-lamination: N/A <input type="checkbox"/> Abrasion: N/A <input checked="" type="checkbox"/> Pop-outs/Spalling: Minor Type: Bug-holing/Sm. <input type="checkbox"/> Scaling: N/A <input type="checkbox"/> Unevenness: N/A <input type="checkbox"/> Cracking: N/A Type: None <input type="checkbox"/> Growth: N/A Type: None <input checked="" type="checkbox"/> Staining: Minor Type: Resin <input type="checkbox"/> Exposed Aggregate: N/A <input type="checkbox"/> Exposed Reinforcement: N/A <input type="checkbox"/> Erosion: N/A Seams/Joints Condition: Good</p>	<p>Corrosion Ratings(%): <input checked="" type="checkbox"/> None: N/A <input type="checkbox"/> Uniform Surface Corrosion: N/A <input type="checkbox"/> Crevice Corrosion: N/A <input type="checkbox"/> Rust Noduling/Pitting: N/A Depth: N/A <input type="checkbox"/> Scaling: N/A <input type="checkbox"/> Other Corrosion(specify): N/A <input type="checkbox"/> Oxidation: N/A Overall Condition: Good Additional Notes: - Minimal discrepancies to note - Minor bug-holing to small pop-outs / spalling present - Minor resin staining localized under manway penetration - Areas of preexisting pop-outs / spalls have since been coated over</p>

- 3.1. Walls - Rehab concrete deterioration (Minor) and touch up areas of coating failure (Minor)
 - 3.2. Access Ladder - Replace corroding hardware (as needed); Ensure access ladder is in compliance with OSHA regulations: 1910.29(b)(13)(i) (No swing gate)

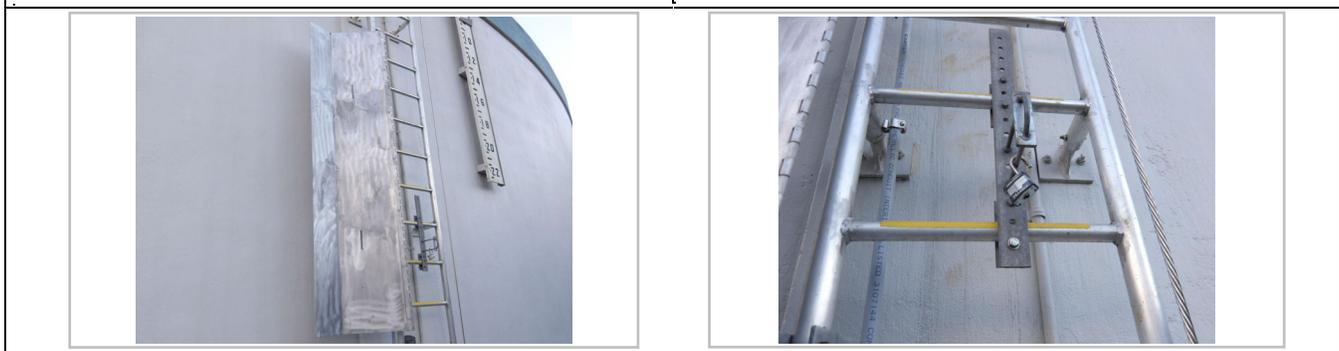
Access Ladder Condition

<p>Ladder Type: Welded Aluminum OSHA Adherence? Y <input checked="" type="radio"/> N <input checked="" type="radio"/> Vandal Guard Present? Y <input checked="" type="radio"/> N <input checked="" type="radio"/> Locked? Y <input checked="" type="radio"/> N <input checked="" type="radio"/> N/A <input checked="" type="radio"/> Safety Climb Type: Guide Cable Coating Present? Y <input checked="" type="radio"/> N <input checked="" type="radio"/> N/A <input checked="" type="radio"/> Ladder Ratings: <input type="checkbox"/> De-lamination: N/A <input type="checkbox"/> Staining: N/A <input type="checkbox"/> Blistering: N/A Type: None <input type="checkbox"/> Chalking: N/A <input type="checkbox"/> Checking: N/A <input type="checkbox"/> Cracking: N/A Type: None <input type="checkbox"/> Pinholes: N/A <input type="checkbox"/> Saggs/Runs: N/A Seams/Welds Condition: Good</p>	<p>Corrosion Ratings(%): <input type="checkbox"/> None: N/A <input checked="" type="checkbox"/> Uniform Surface Corrosion: Approx. < 1% <input type="checkbox"/> Crevice Corrosion: N/A <input type="checkbox"/> Rust Noduling/Pitting: N/A Depth: N/A <input type="checkbox"/> Scaling: N/A <input type="checkbox"/> Other Corrosion(specify): N/A <input checked="" type="checkbox"/> Oxidation: Approx. < 2% Standoff Supports Condition: Good Overall Condition: Good Additional Notes: - NOT in compliance w/ OSHA regulation 1910.29(b)(13)(i) * INSTALL SWING GATE * - All aluminum makeup w/ galvanized steel vandal guard hardware - Anti slip pads on every rung - Stainless steel safety climb system - Minor oxidation & corrosion localized throughout hardware</p>

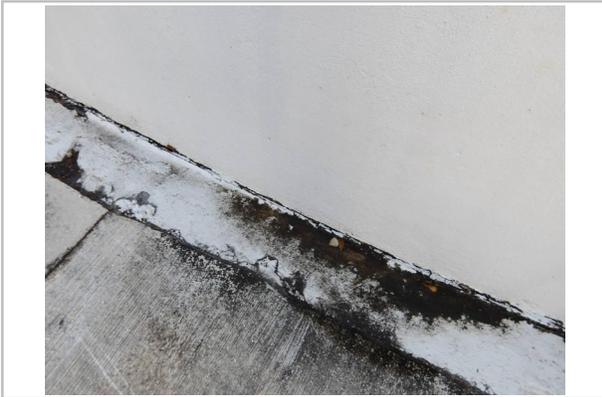
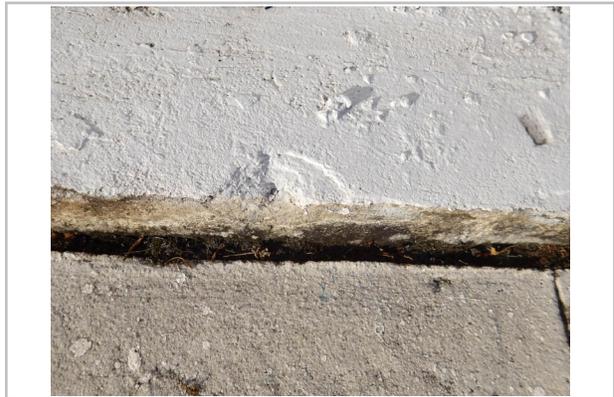
Foundation Condition

- De-lamination: Moderate
- Abrasion: N/A
- Pop-outs/Spalling: Minor Type: Bug-holing/Sm.
- Scaling: N/A
- Unevenness: N/A
- Cracking: N/A Type: None
- Growth: Minor Type: Organic
- Staining: Moderate Type: Weather
- Exposed Aggregate: Moderate
- Exposed Reinforcement: N/A
- Erosion: N/A

- Moderate coating failure in the forms of d-lamination
- Minor bug-holing to small pop-outs / spalling unlocalized throughout
- Moderate gasket deterioration @ foundation to wall seam
- Moderate weather staining unlocalized throughout

- 3.3. Foundation - Replace/ rehab deteriorating gasket (Mod); Rehab areas of concrete deterioration (Mod)
 - 3.4. FLI - Replace or repair (Missing/ broken components (interior & exterior)/ No longer accurate)

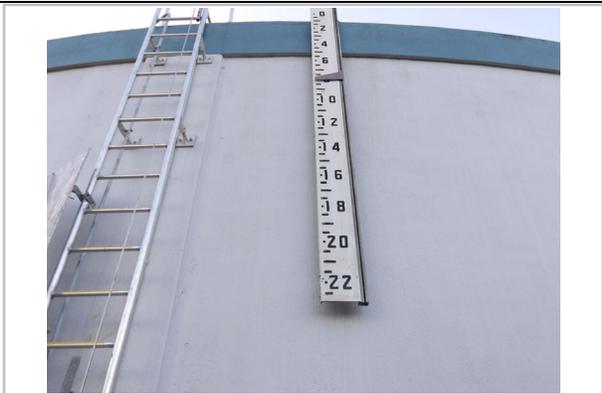
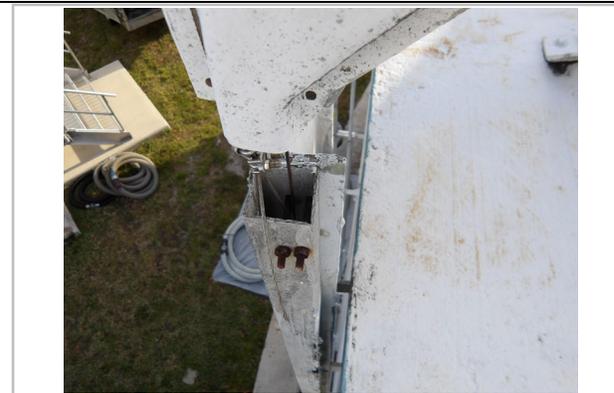
Float Level Indicator Condition

Pulley Condition: Poor
 Attached Properly? Y N

Cable Condition: Poor
 Attached Properly? Y N
 Overall Hardware Condition: Fair to Poor

Overall Condition: Poor

- Overall missing many components, no longer accurate
- Oxidation & corrosion localized throughout hardware
- Minor organic growth present
- Minor to moderate d-lamination, exposing fiberglass

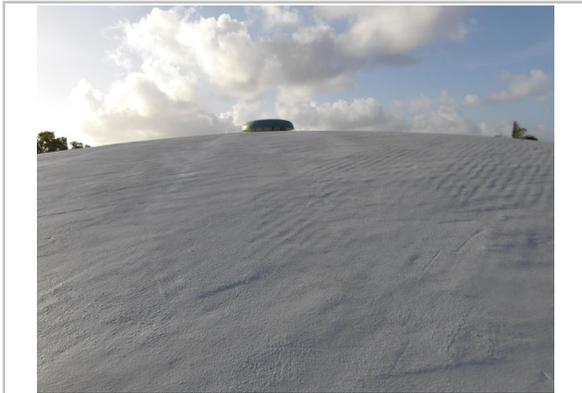
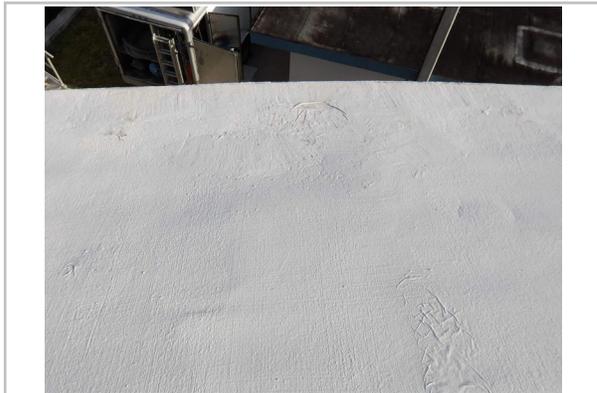
Roof Condition

- Moderate small to large blistering unlocalized throughout
- Minor unevenness unlocalized throughout
- Minor weather staining present
- Minor d-lamination noted throughout protective coating

- 3.5. Roof - Touch-up / spot repair areas of coating failure (Minor)
 - 3.6. Vent - Treat areas of corrosion (Minor); Replace corroding hardware (as needed)

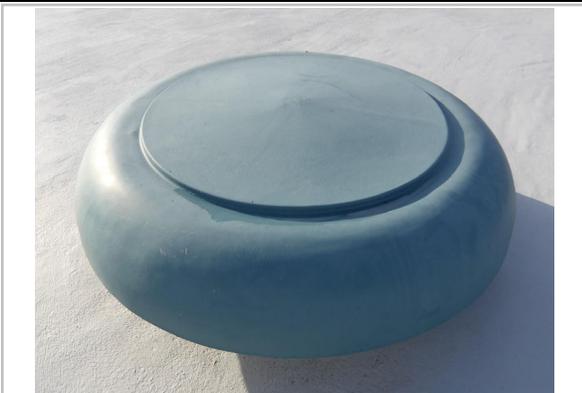
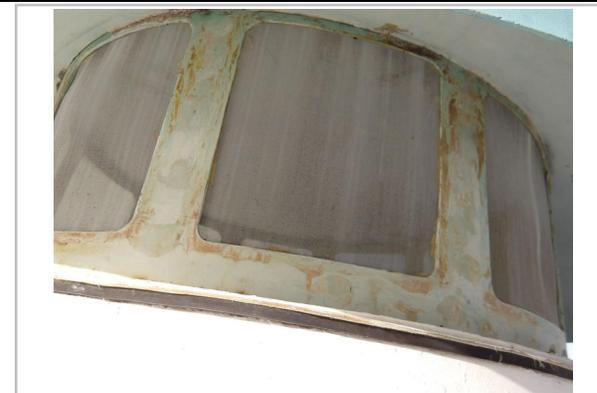
Vent Condition

- Oxidation & corrosion localized throughout hardware
- Newer blue coating applied to top side of the cap
- Minor residual adhesive on screen areas

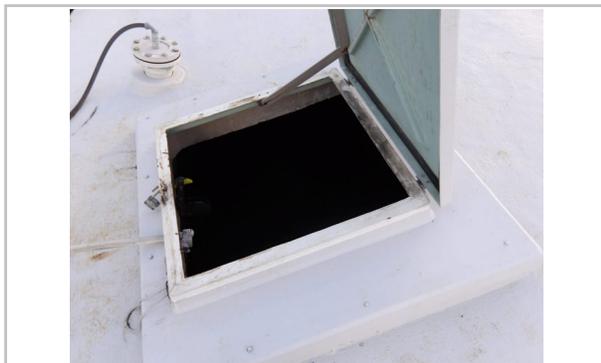
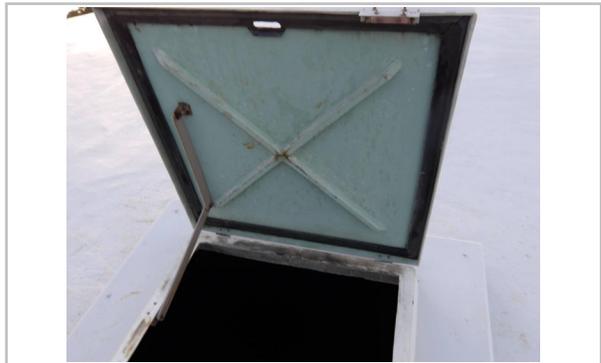
Access Hatch Condition

Corrosion Ratings(%):
 None: N/A
 Uniform Surface Corrosion: Approx. < 2%
 Crevice Corrosion: N/A
 Rust Noduling/Pitting: N/A
 Scaling: N/A
 Other Corrosion(specify): N/A
 Oxidation: Approx. < 3%
 Depth: N/A
Seams/Welds Condition: Good
 Insects, Dirt or Debris Present Under Hatch? Y N
 Any irregularities or structural deficiencies? Y N
 Description: Structural Cracking
Overall Condition: Good to Fair
Additional Notes:
 - Fiberglass shoe box construction with a fully intact gasket
 - Oxidation & corrosion localized throughout hardware
 - Hairline / structural cracking localized on center of hatch interior

- 3.7. Access Hatch - Repair/ seal crack (center interior); Replace corroding hardware (as needed)
 - 3.8. Overflows - Spot repair areas of concrete deterioration (Minor)

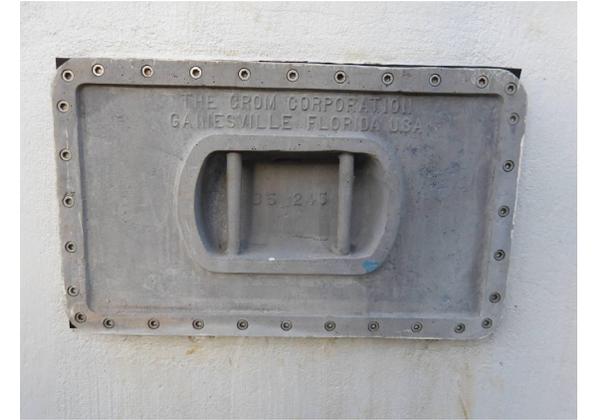
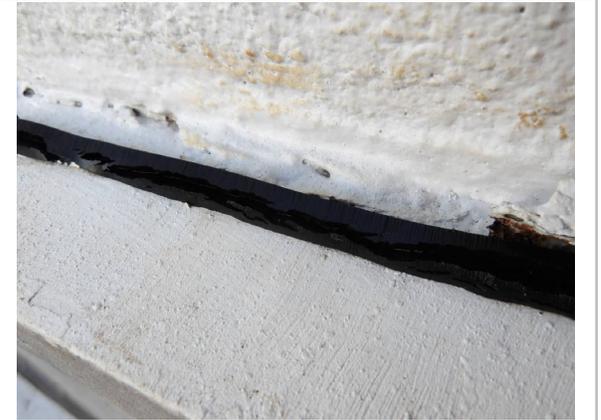
Manway Condition

Corrosion Ratings(%):
 None: N/A
 Uniform Surface Corrosion: N/A
 Crevice Corrosion: N/A
 Rust Noduling/Pitting: N/A
 Scaling: N/A
 Other Corrosion(specify): N/A
 Oxidation: N/A
 Depth: N/A
Overall Condition: Good
Additional Notes:
 - Made of a galvanized steel lid w/ stainless steel hardware
 - Minor weather staining noted
 - Moderate gasket deterioration present

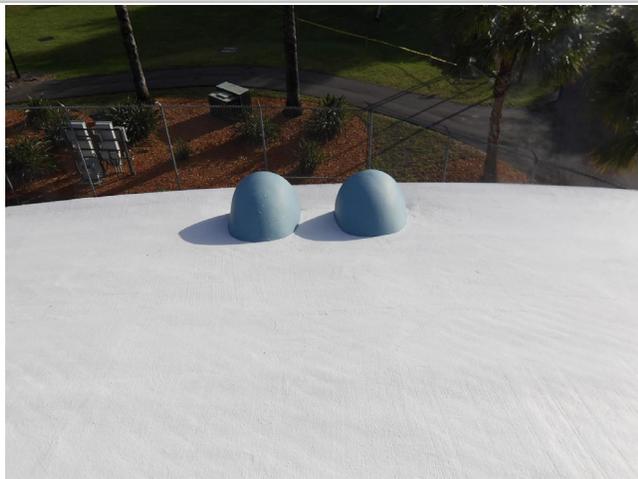
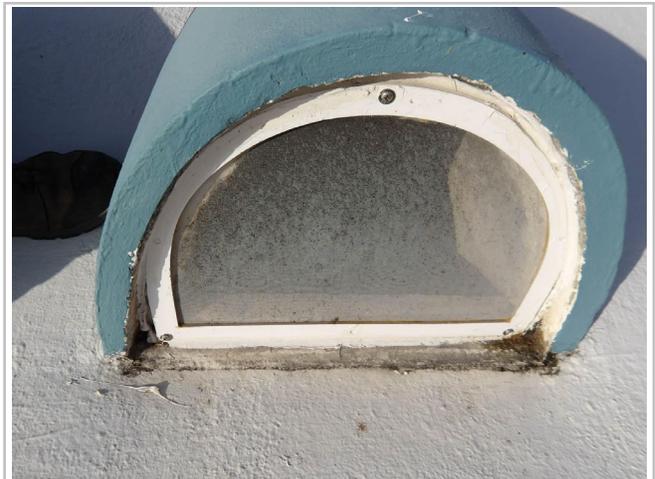
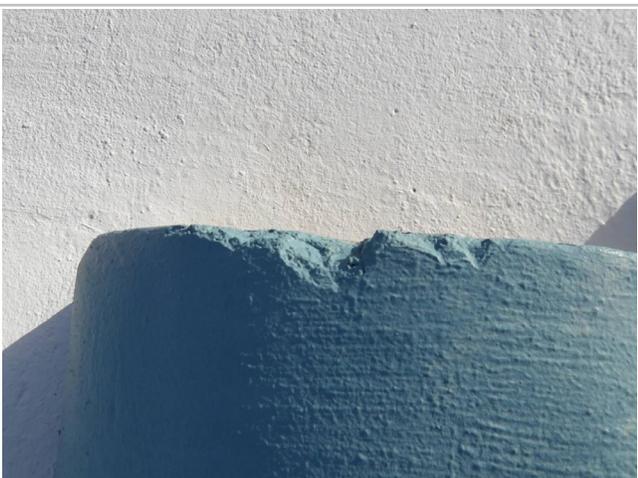
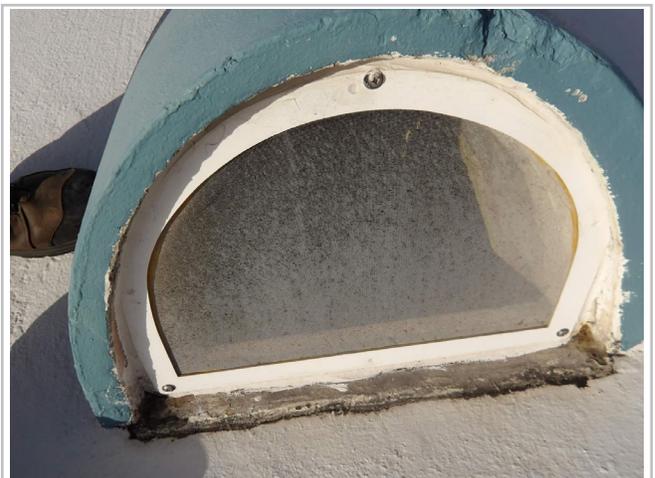
Overflow Structure Condition

- Minor bug-holing to small pop-outs / spalling present
- Minor abrasion noted
- Minor weather staining present
- Screen material appears to be relatively new

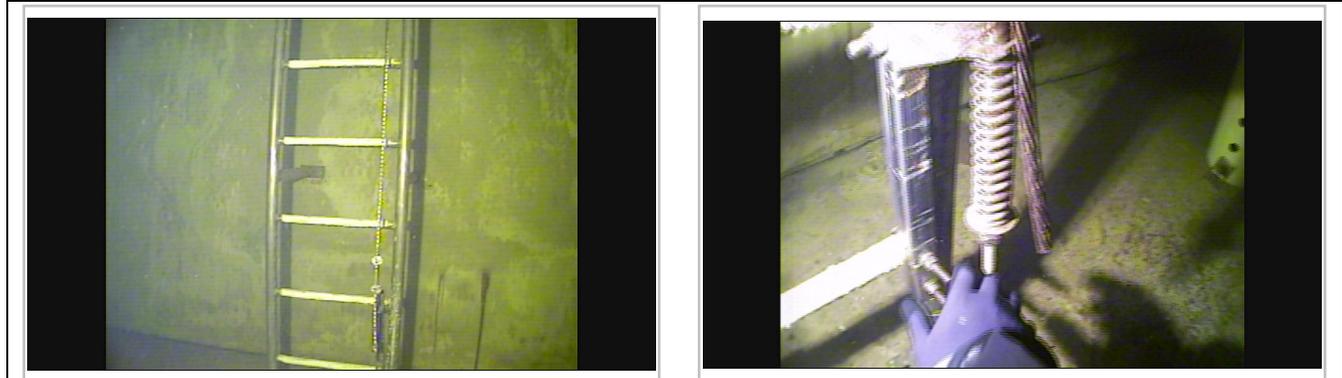
Ladder Condition

<p>Ladder Location: 12:00</p> <p>Ladder Ratings:</p> <p><input type="checkbox"/> De-lamination: N/A</p> <p><input checked="" type="checkbox"/> Staining: Minor</p> <p><input type="checkbox"/> Blistering: N/A</p> <p><input type="checkbox"/> Chalking: N/A</p> <p><input type="checkbox"/> Checking: N/A</p> <p><input type="checkbox"/> Cracking: N/A</p> <p><input type="checkbox"/> Growth: N/A</p> <p><input type="checkbox"/> Pinholes: N/A</p> <p><input type="checkbox"/> Saggs/Runs: N/A</p> <p>Seams/Welds Condition: Good</p>	<p>Coating Present? Y <input type="radio"/> N <input checked="" type="radio"/></p> <p>Type: None</p> <p>Type: None</p> <p>Type: None</p> <p>Corrosion Ratings(%):</p> <p><input type="checkbox"/> None: N/A</p> <p><input checked="" type="checkbox"/> Uniform Surface Corrosion: Approx. < 1%</p> <p><input type="checkbox"/> Crevice Corrosion: N/A</p> <p><input type="checkbox"/> Rust Noduling/Pitting: N/A</p> <p><input type="checkbox"/> Scaling: N/A</p> <p><input type="checkbox"/> Other Corrosion(specify): N/A</p> <p><input checked="" type="checkbox"/> Oxidation: Approx. < 2%</p> <p>Overall Condition: Good</p> <p>Additional Notes:</p> <ul style="list-style-type: none"> - Ladder equipped w/ cable safety climb - Oxidation & corrosion localized throughout hardware - Isolated oxidation on the safety cable climb system - Ladder made of aluminum w/ stainless steel hardware - Minor to moderate sediment staining present <p style="text-align: right;">Depth: N/A</p>

4. Interior:
 - 4.1. Roof - Repair/ seal areas of cracking (Minor); Spot repair areas of concrete deterioration (Minor); Apply protective coating
 - 4.2. Ladder - Treat areas of corrosion (Minor); Replace corroding hardware (as needed)

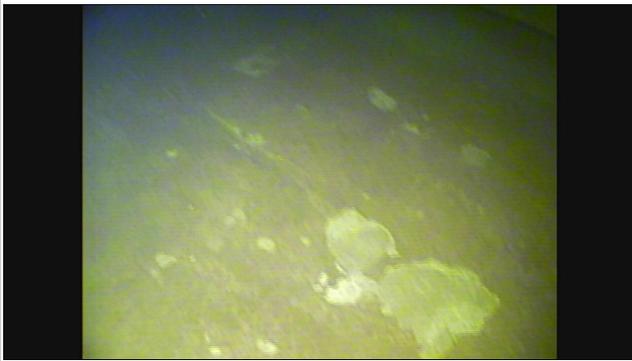
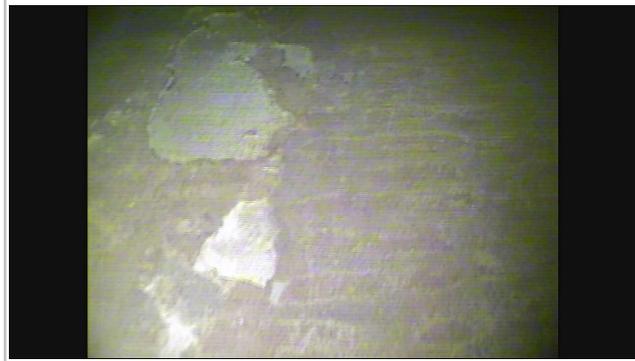
Floor Condition

- De-lamination: N/A
- Abrasion: N/A
- Pop-outs/Spalling: Minor Type: Small / Medium
- Scaling: Moderate
- Unevenness: N/A
- Cracking: N/A Type: None
- Growth: N/A Type: None
- Staining: Minor Type: Sediment
- Exposed Aggregate: Moderate
- Exposed Reinforcement: N/A
- Erosion: N/A

- Moderate concrete scaling unlocalized throughout
- Minor to moderate abrasion unlocalized throughout
- Minor sediment staining throughout
- Minor to moderate small to medium pop-outs / spalling
- Moderate exposed aggregate noted

- 4.3. Floor - Rehab areas of concrete deterioration (Minor/ Mod); Apply protective coating
 - 4.4. Drain - Treat areas of corrosion/ rust noduling (Mod); Apply protective coating

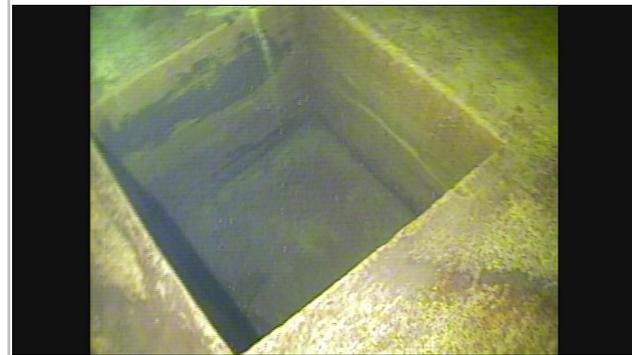
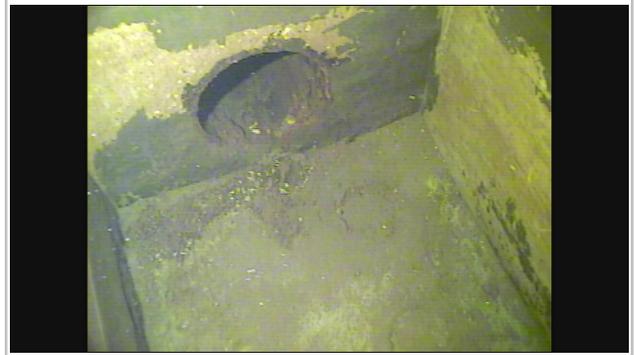
Drain Condition

- None: N/A
- Uniform Surface Corrosion: Approx. < 20% Depth: 1/16"
- Crevice Corrosion: N/A
- Rust Noduling/Pitting: Approx. < 10%
- Scaling: N/A
- Other Corrosion(specify): N/A
- Oxidation: Approx. < 25%

- Drain sits in a sump
- Approx. 12" pipe
- Sump area approx. 3' x 3' x 3'
- Oxidation, corrosion, & rust noduling unlocalized throughout
- Moderate corrosive / sediment staining present

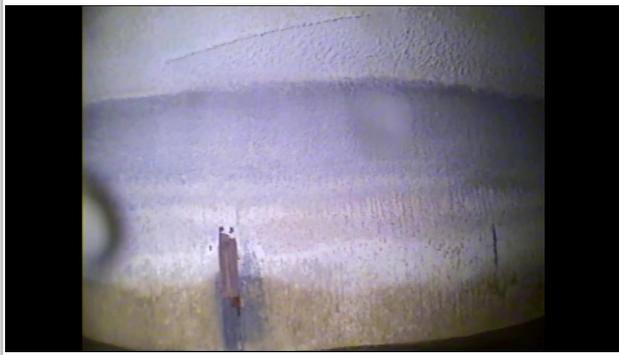
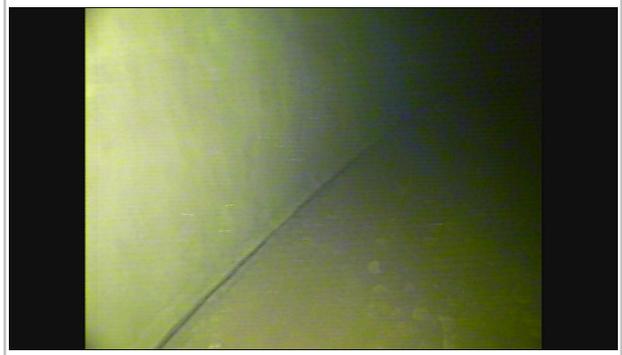
Wall Condition

- De-lamination: N/A
- Abrasion: N/A
- Pop-outs/Spalling: Minor
- Scaling: Minor
- Unevenness: N/A
- Cracking: Moderate
- Growth: Minor
- Staining: Minor
- Exposed Aggregate: N/A
- Exposed Reinforcement: N/A
- Erosion: N/A
- Saggs/Runs: N/A

- Minor to moderate hairline / settling cracking present
- Multiple wood forms & portions of resin noted in wall
- Minor scaling unlocalized throughout upper wall
- Minor sediment satining throughout
- Minor mineral growth localized throughout cracking

- 4.5. Wall - Repair/ seal areas of cracking (Mod); Rehab areas of concrete deterioration (Minor scaling/ spalling) and apply protective coating
 - 4.6. Inlet - Repair exposed reinforcement (Minor); Rehab concrete deterioration (concrete saddle supports/ Minor); Replace corroding hardware (as needed)

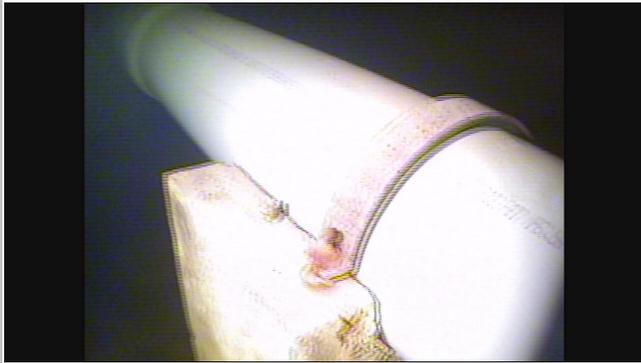
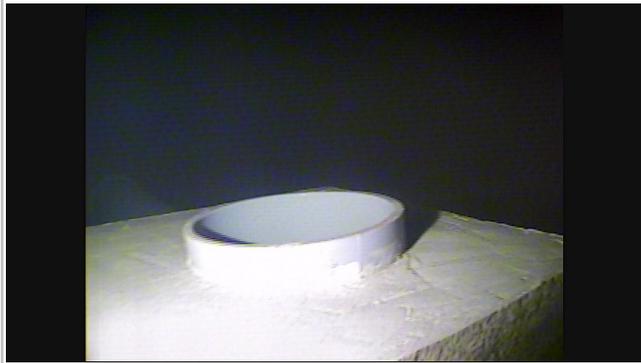
Inlet Condition

Corrosion Ratings(%):
 None: N/A
 Uniform Surface Corrosion: Approx. < 4%
 Crevice Corrosion: N/A
 Rust Noduling/Pitting: Approx. < 3% Depth: 1/16"
 Scaling: Approx. < 1%
 Other Corrosion(specify): N/A
 Oxidation: Approx. < 5%
Overall Condition: Good to Fair
Additional Notes:
 - Made of PVC w/ minimal discrepancies noted
 - Concrete saddle supports contain concrete scaling, erosion, & spalling
 - Oxidation & corrosion localized throughout hardware
 - Inlet pipe embedded in concrete @ discharge point
 - Minor corrosive / sediment staining noted
 - Minor exposed reinforcements localized in concrete supports

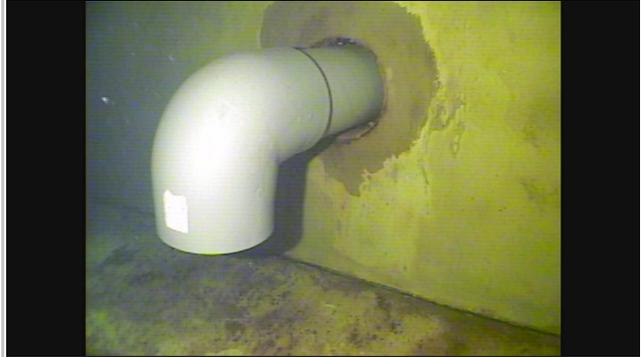
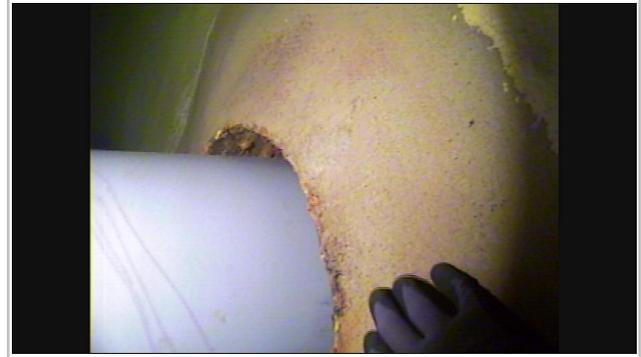
Outlet Condition

Corrosion Ratings(%):
 None: N/A
 Uniform Surface Corrosion: Approx. < 8%
 Crevice Corrosion: N/A
 Rust Noduling/Pitting: Approx. < 5% Depth: 1/16"
 Scaling: N/A
 Other Corrosion(specify): N/A
 Oxidation: Approx. < 10%
Overall Condition: Good to Fair
Additional Notes:
 - Made of PVC plastic w/ minimal discrepancies
 - Oxidation, corrosion, & rust noduling localized around penetration
 - Penetrates approx. 2' above floor & turns down 90°
 - Minor sediment / corrosive staining noted

- 4.7. Outlet - Treat areas of corrosion/ rust noduling (Minor/ Mod)
 - 4.8. FLI - *See note above*
 - 4.9. Overflow - Rehab areas of concrete deterioration (Minor pop-outs/ bug-holing/ spalling) and apply protective coating

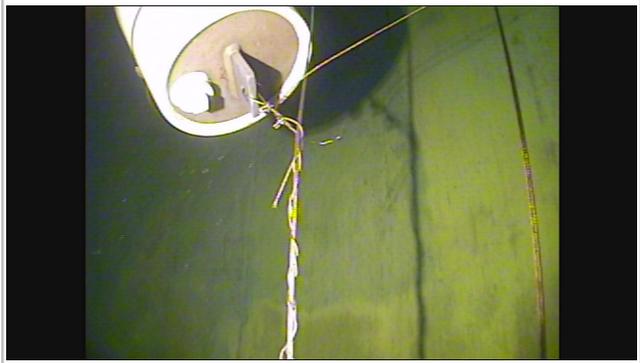
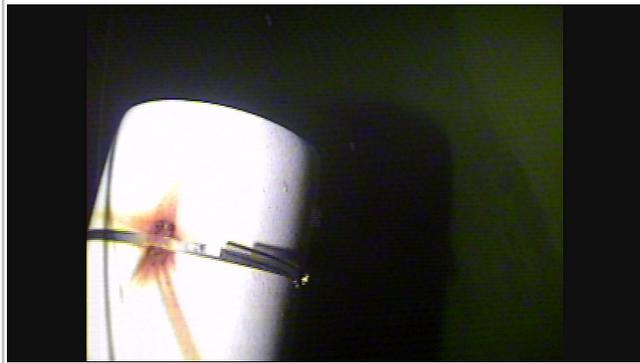
Float Condition

Float Location: 12:45
Float Condition: Fair
 Float Sealed? Y N
 Guidelines Condition: Good to Fair
 Attached Properly? Y N
 Cable Condition: Poor
 Attached Properly? Y N
 Hardware Condition: Poor
Coating Condition: Good to Fair

Corrosion Ratings(%):
 None: N/A
 Uniform Surface Corrosion: Approx. < 8%
 Crevice Corrosion: N/A
 Rust Noduling/Pitting: Approx. < 2% Depth: N/A
 Scaling: N/A
 Other Corrosion(specify): N/A
 Oxidation: Approx. < 10%
Overall Condition: Poor
Additional Notes:
 - Minor oxidation, corrosion, & rust noduling present on float & hardware
 - Float is not guided by the guide wires & is tangled around them
 - Roof penetrations are discrepancy free
 - Float has failed

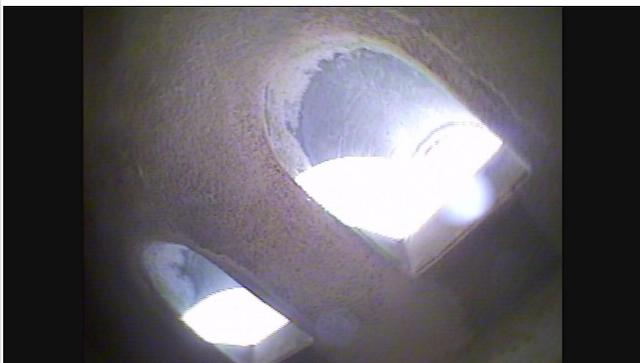
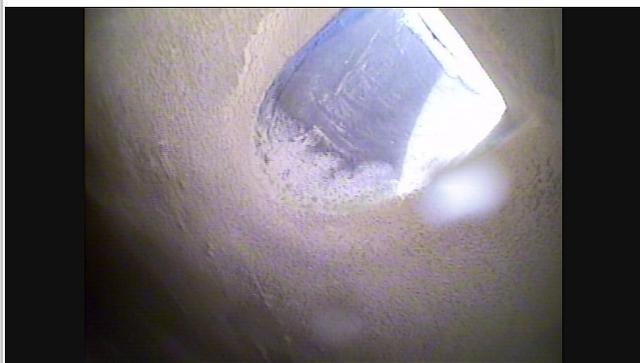
Overflow Condition

Corrosion Ratings(%):
 None: N/A
 Uniform Surface Corrosion: N/A
 Crevice Corrosion: N/A
 Rust Noduling/Pitting: N/A
 Scaling: N/A
 Other Corrosion(specify): N/A
 Oxidation: N/A
Overall Condition: Good to Fair
Additional Notes:
 - Tank equipped w/ two(2) frog eye overflows
 - Minor seam deterioration present
 - Minor bug-holing to small pop-outs / spalling
 - Screen material fully intact on both overflows

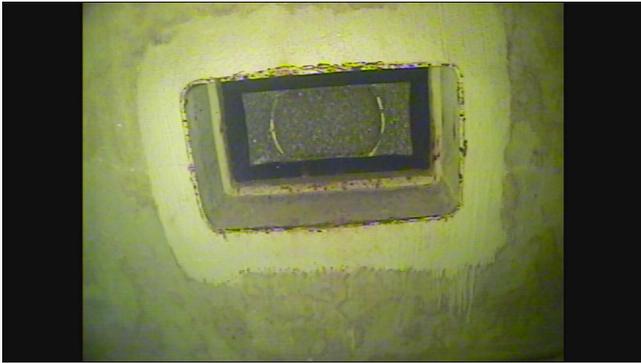
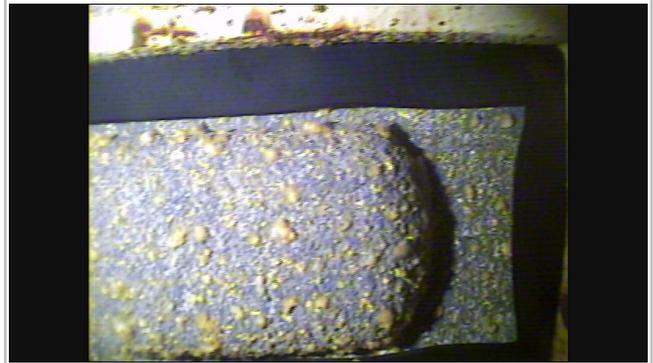
Manway Condition

- None: N/A
- Uniform Surface Corrosion: Approx. < 15%
- Crevice Corrosion: N/A
- Rust Noduling/Pitting: Approx. < 30% Depth: 1/16"
- Scaling: N/A
- Other Corrosion(specify): Galv: Approx. < 50%
- Oxidation: Approx. < 65%

- Moderate to heavy galvanic corrosion & rust noduling present on lid
- Moderate gasket deterioration present
- Oxidation, corrosion, & rust noduling noted throughout steel insert
- Minor corrosive / sediment staining present
- Minor to moderate d-lamination unlocalized throughout

Gasket Condition: Poor

- 4.10. Manway - Replace deteriorating gasket (Mod); Treat areas of corrosion (Mod/ Heavy); Rehab/ replace failing protective coating (Mod)

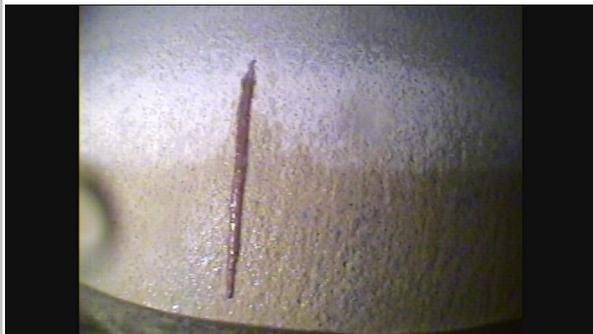
Resin Inside Reservoir

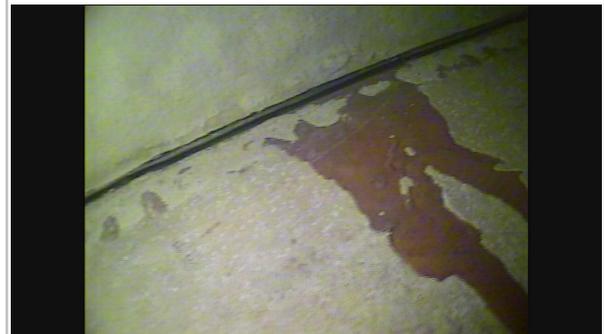
Resin Inside Reservoir

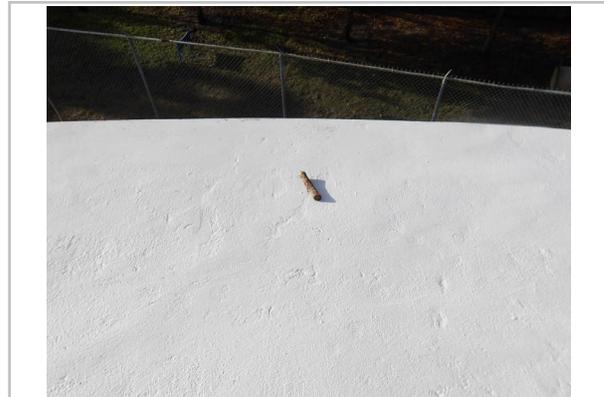
Debris on Roof
