Roof Asset Management Program

6280 W. Atlantic Inspection

*6280 W. Atlantic / Main / Photo Report: Oct 17, 2016 - Visual Inspection* .....7

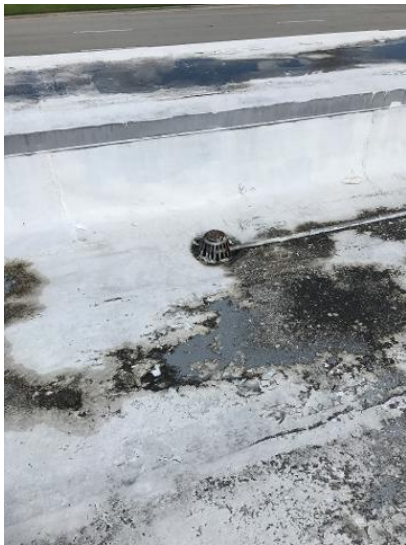
**Photo 1**

Multiple coating failures.

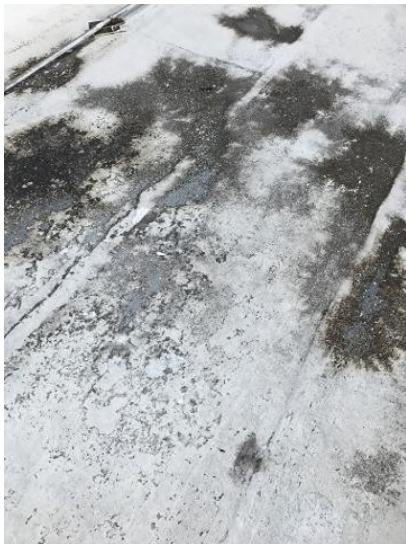
**Photo 2**

Seams have been reinforced with coating and scrim.

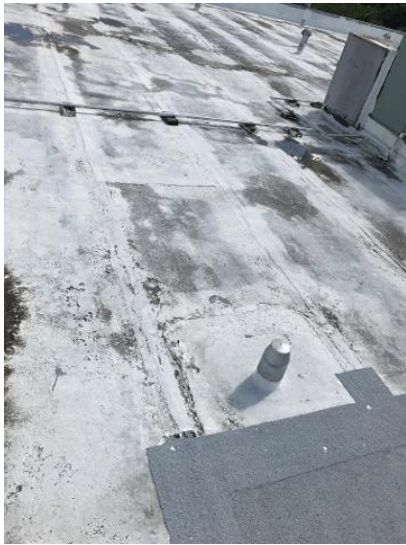
**Photo 3**

Large repair perviously made.

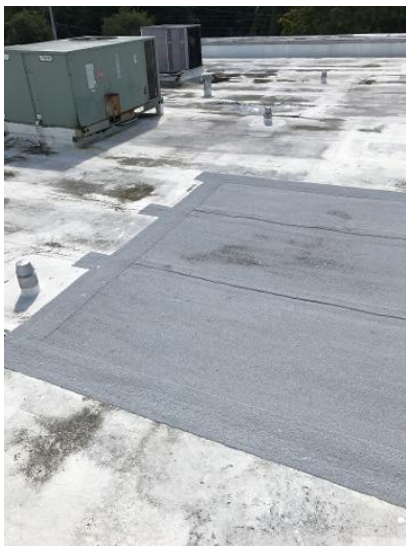
**Photo 6**

Previous repair made.

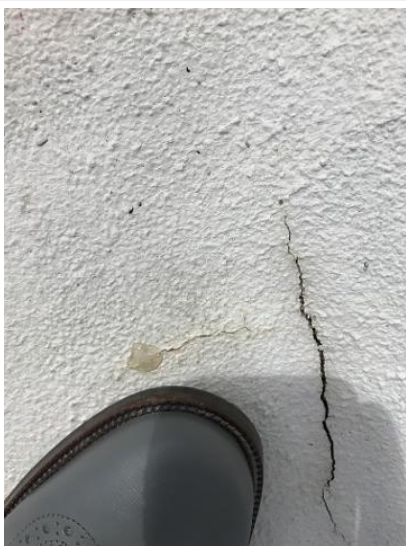
**Photo 7**

Membrane failure, cracks in the membrane due to asphalt drying out of the cap sheet.

Action Year:	2016
Square Footage:	3,677	Expected Life Years:	2
Budget Range:	\$3,400.00 - \$4,200.00		
Three course all failed seams. Three course all cracked membrane sections. Torch over failed membrane where needed. Top off all pitch pockets.

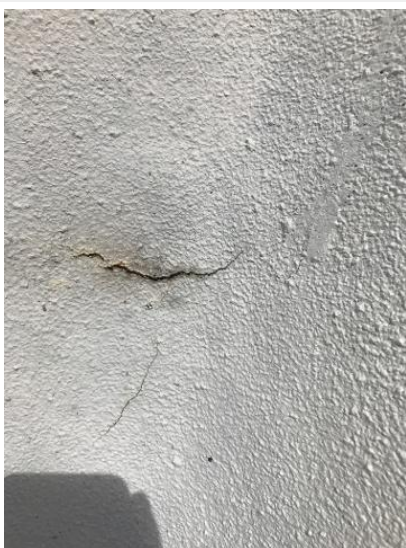
**Photo 8**

Crack in the membrane, holding water.

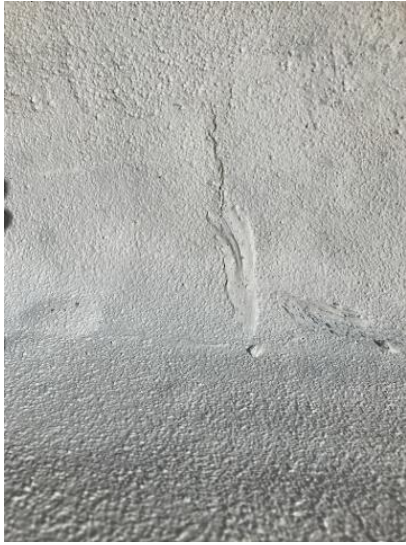
**Photo 9**

Cracks along the perimeter flashings perviously improperly repaired with caulk.

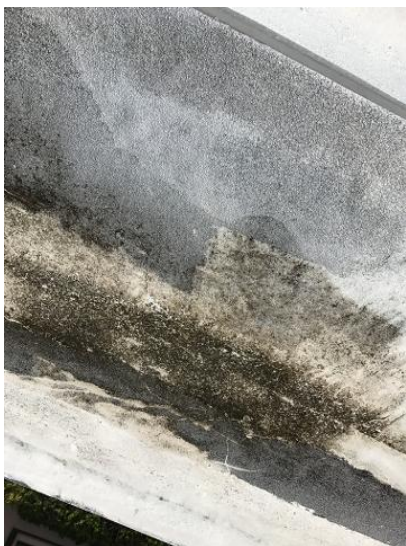
**Photo 11**

Failed coating.

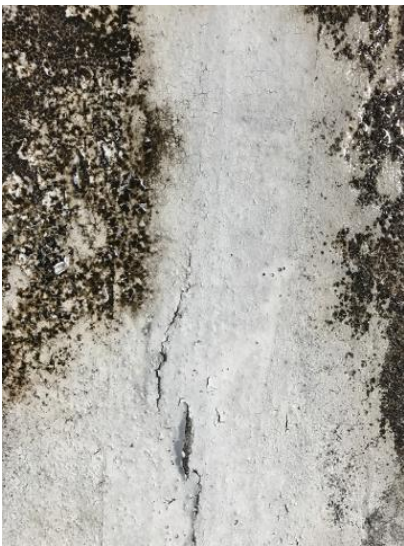
**Photo 14**

Failed coating and repair.

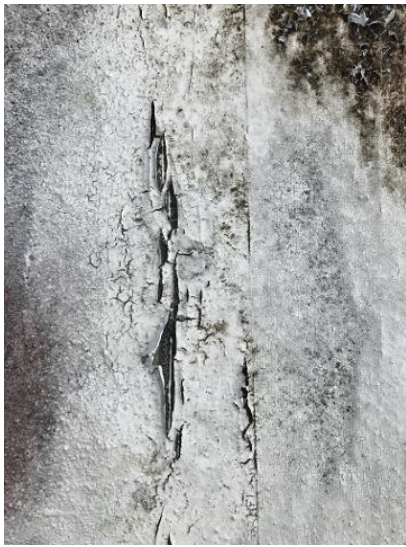
**Photo 16**

Failed coating.

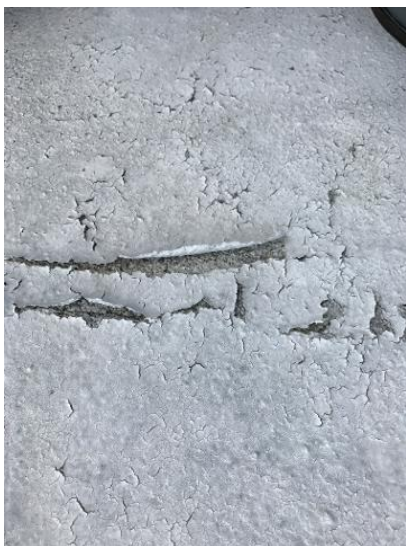
**Photo 17**

Failed coating.

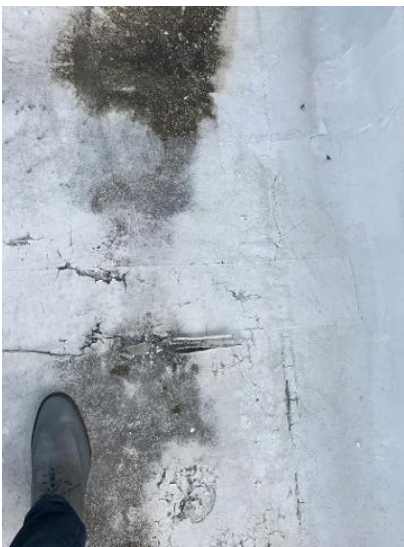
**Photo 19**

Multiple failed layers of coating.

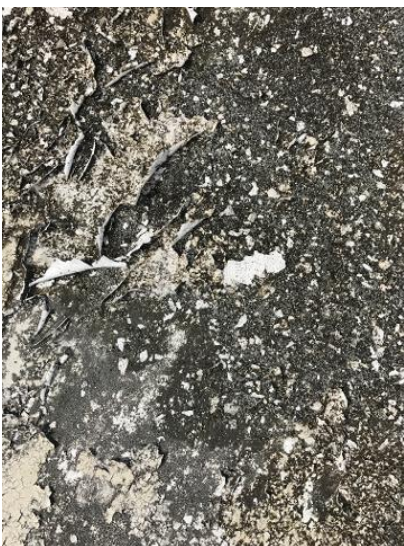
**Photo 23**

Failed coating.

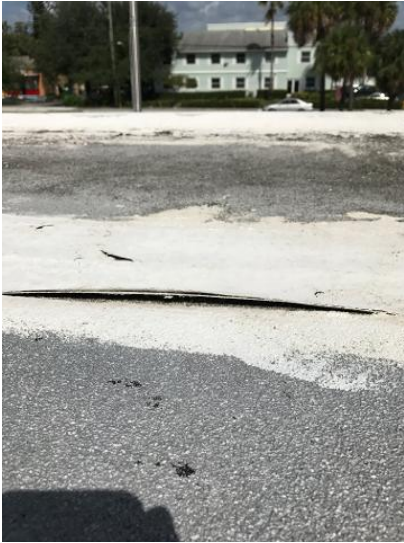
**Photo 24**

Failed coating.

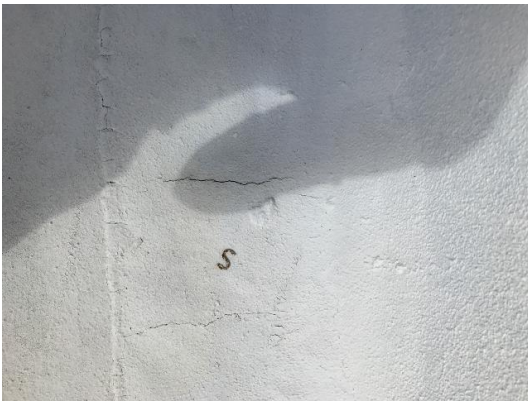
**Photo 25**

Cracks in the perimeter flashing.
