Phase I Environmental Site Assessment for Carolina Club 3011 N Rock Island Road, Margate, FL

Prepared for: Rosemurgy Acquisitions, LLC

WGI Project No. 10469.00

Report Issuance Date: March 21, 2024 Report Expiration Date: August 27, 2024

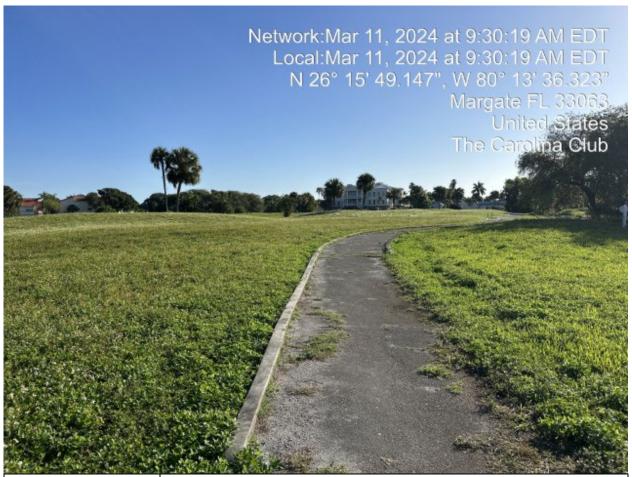
Photo Number: 1
Photo date: 3/11/2024

Inactive golf course. Inactive club house in the background. Asphalt golf cart path.

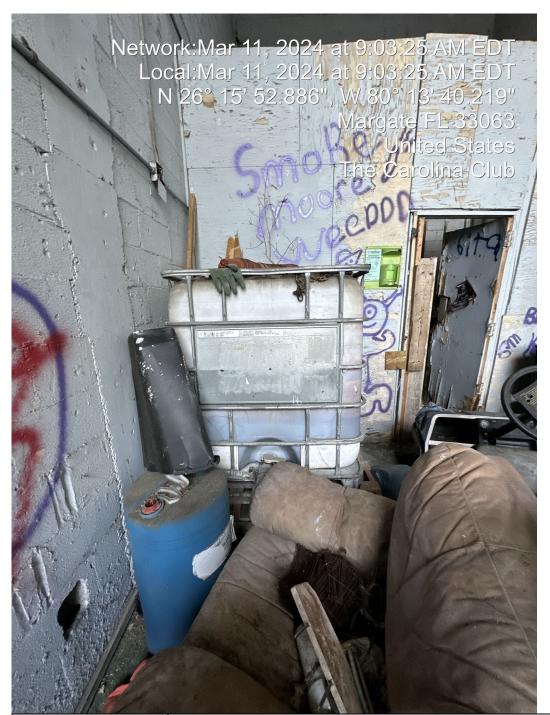
Photo Number: 3 Photo date: 3/11/2024

IBC tank outside of the chemical storage room. Door to chemical storage room evident at right. Near the southeast corner of the maintenance building.

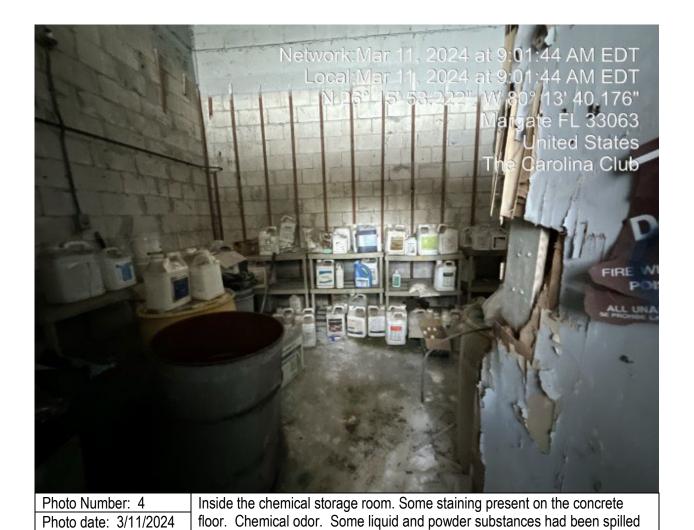
on the concrete floor.

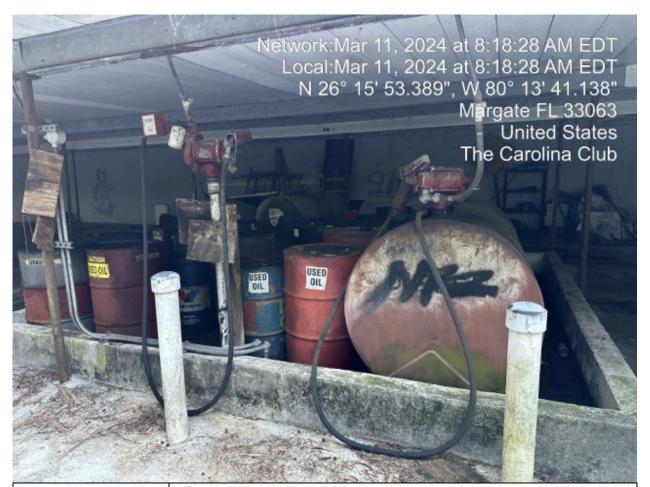
Photo Number: 5
Photo date: 3/11/2024

AST and drum storage area - on the north side of the maintenance building - under a roof. Diesel AST at right. Drums of waste oil and oily rags. Behind the diesel AST is a waste oil AST and some other ASTs which appear to be inactive and empty. ASTs and the majority of the oil drums are within a concrete secondary containment wall. Heavy staining inside the containment wall, but no evidence of a release through or over the containment wall. Gasoline UST is under the concrete pad in the foreground (not evident in this photo).

- There are several 55-gallon drums of hazardous substances or petroleum products, primarily or entirely
 waste oil, at the maintenance building next to the AST and UST. WGI found no evidence of a significant
 release from these containers.

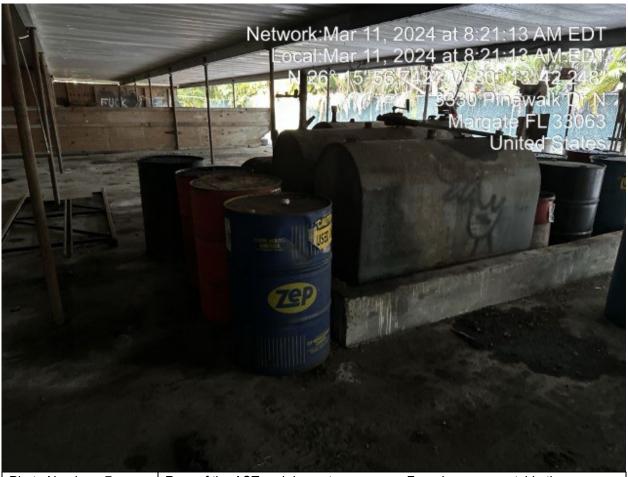
Photo Number: 7
Photo date: 3/11/2024

Rear of the AST and drum storage area. Four drums are outside the secondary containment wall.

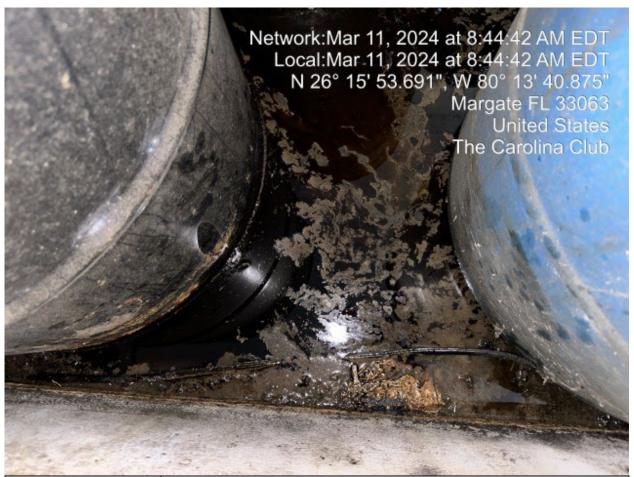
Photo Number: 8
Photo date: 3/11/2024
Direction: down

Inside the secondary containment of the AST and drum storage area. Heavy staining of the concrete floor, and approximately 1 gallon of oily water on the concrete floor – apparent mix of rainwater and waste oil.

Oily water and stained concrete at the maintenance area within the secondary containment wall of the AST and drum storage area. De minimis conditions are related to a release but generally do not present a threat to human health or the environment and generally would not be the subject of an enforcement action if brought to the attention of appropriate governmental agencies.

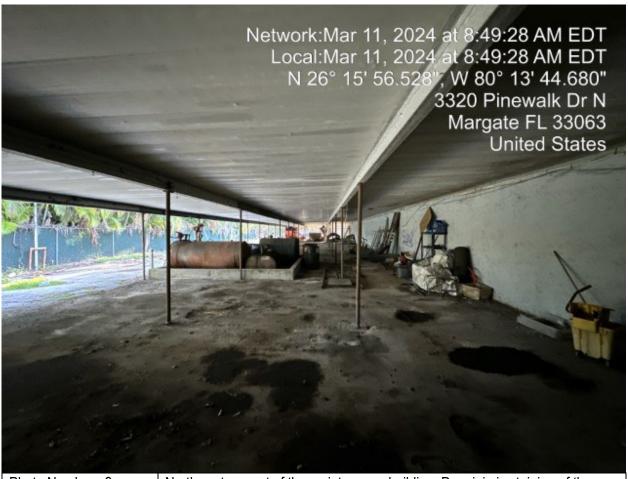
Photo Number: 9
Photo date: 3/11/2024

Northwestern part of the maintenance building. De minimis staining of the concrete floor. AST and drum storage area is evident in the background.

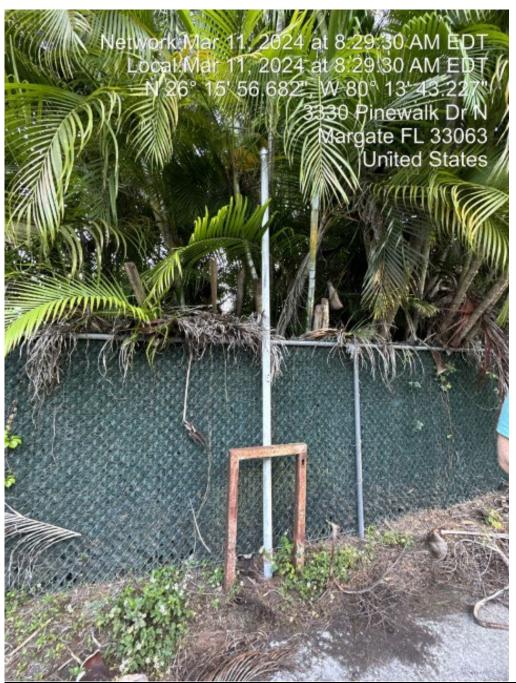
Photo Number: 10 Photo date: 3/11/2024

Vent pipe for the gasoline UST. North of the maintenance building next to the AST and drum storage area.

- Tank #4 (Remains): Broward County records indicate there is a 600 gallon underground storage tank (UST) for gasoline located at the site; Broward County records indicate it was installed in December 1992 and is a double-wall fiberglass tank. It remains in service. The UST is periodically inspected by FDEP; the most recent UST inspection was on 3/3/2023; that inspection revealed several violations related to spill bucket corrosion, inadequate annual release detection and integrity testing, and similar issues. The UST is on the north side of the maintenance building.

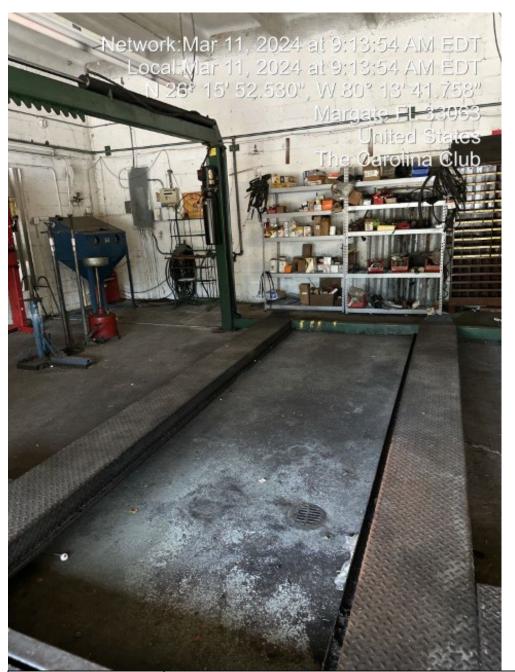
Photo Number: 11 Photo date: 3/11/2024

Above ground hydraulic lift inside the south side of the maintenance building – at the mechanics shop.

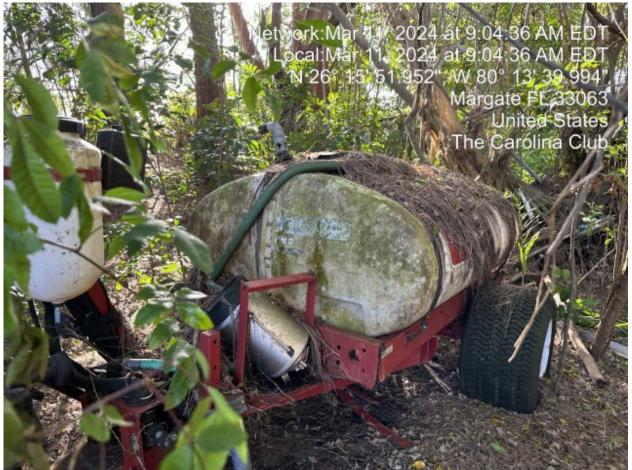
Photo Number: 13 Photo date: 3/11/2024

Abandoned sprayer along the southern side of the maintenance area.

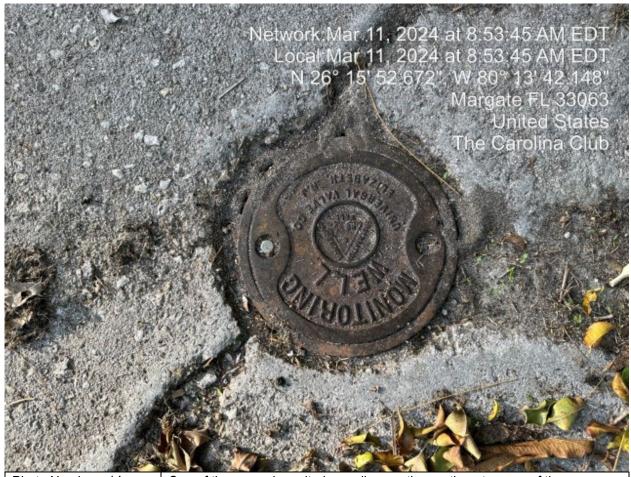
Photo Number: 14
Photo date: 3/11/2024

One of the several monitoring wells near the southeast corner of the maintenance building.

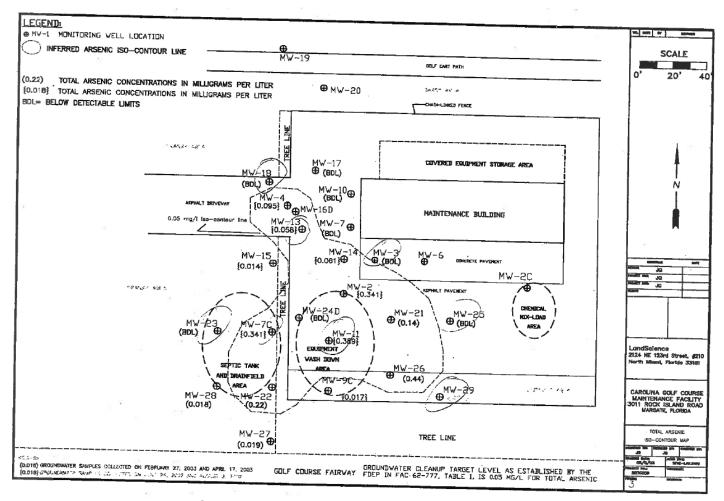
Extent of arsenic in groundwater at the maintenance building in 2003

The arsenic iso-concentration line was based on the old GCTL of 0.050 mg/L, not the new GCTL of 0.010 mg/L. These data are from February and April 2003. The maximum concentration during these sampling periods was 0.440 mg/L (440 ug/L) in MW-26.

- REC 2: Presence of Arsenic outside the Maintenance Area. A Site Assessment Report Addendum (SARA) dated May 29, 2003 delineated soil and groundwater contamination from arsenic at the maintenance building, but also stated that the soil contamination is slightly outside the main area because elevated arsenic levels were also found in borings SB-19, 20, and 21. At 0 feet to 2 feet the arsenic levels ranged from 9.4 mg/kg to 26.0 mg/kg and at 4 feet to 6 feet below the surface samples ranged from 3.0 mg/kg to 3.8 mg/kg. On April 26, 2007 Broward County Engineering and Permitting Division noted that arsenic impacts to the soil were not limited to just the maintenance building area, so the intended golf-course-only restriction should apply to the entire property. The DRC dated April 17, 2008 (provided in Appendix F) appears to specify that the entire golf course shall remain a golf course. WGI conducted soil and groundwater sampling during a previous due diligence effort in 2018; that due diligence effort was terminated and the results were not assembled into a Phase II ESA at that time. The data were later compiled into a Phase II ESA dated March 2024 concurrent with this Phase I ESA. The soil data reveal arsenic in soil above residential and/or commercial soil cleanup target levels (SCTLs) and above synthetic precipitation leaching procedure (SPLP) leachability criteria in numerous locations on the golf course. The Phase II ESA testing also found that the groundwater has arsenic above its GCTL in multiple locations. WGI considers the presence of arsenic outside the maintenance area as a REC because soil and groundwater sampling data indicate the arsenic extends beyond the maintenance area.

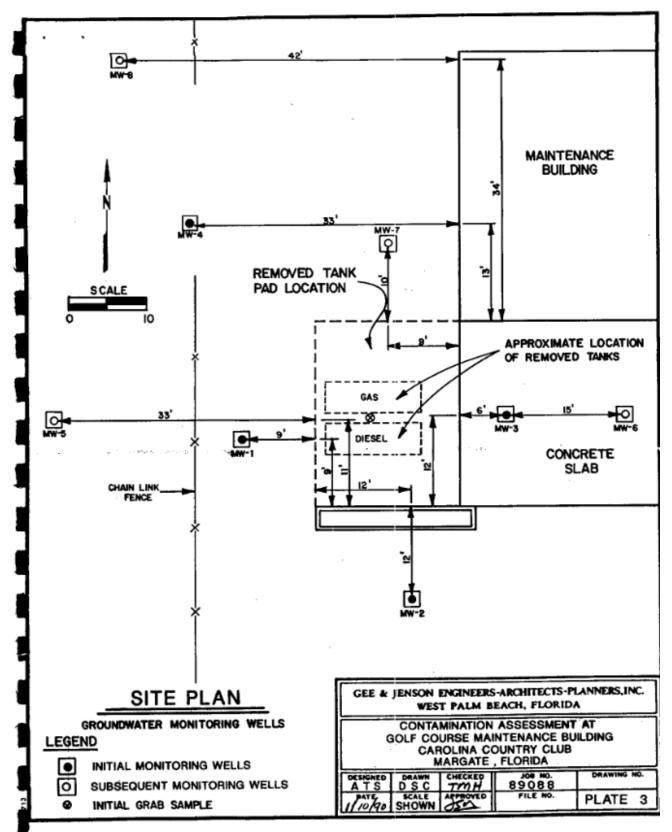
Location of former USTs - southwest corner of maintenance building, 1990

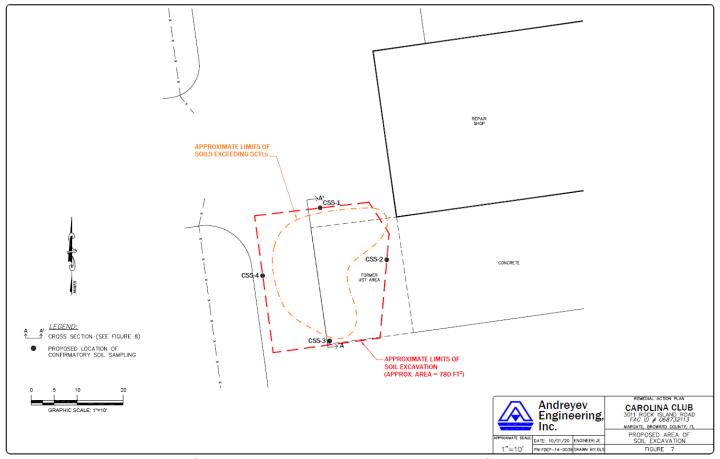
Extent of PAH soil contamination - southwest corner of maintenance building

Recent / current (2020) conditions Source: Limited Scope Remedial Action Plan dated 10/2/2020

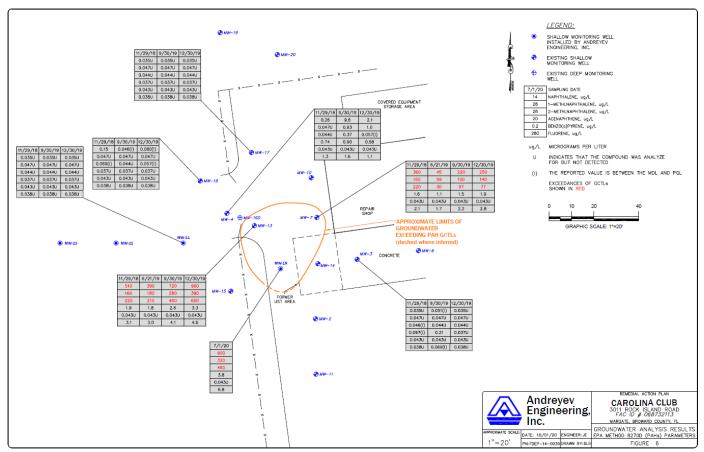
Extent of PAH groundwater plume - southwest corner of maintenance building

Recent / current (2020) conditions Source: Limited Scope Remedial Action Plan dated 10/2/2020

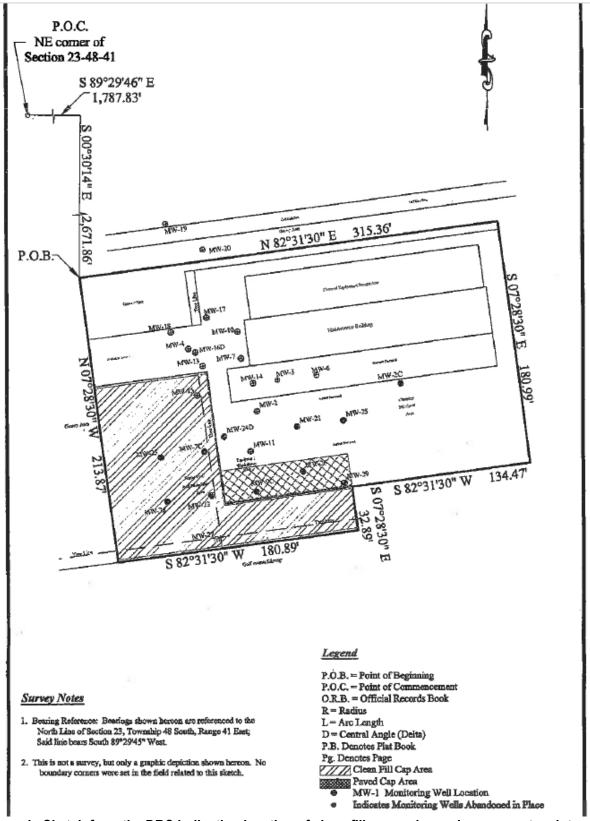
Figure 4. Sketch from the DRC indicating location of clean fill cap and paved cap area at maintenance area. (source: Institutional Controls and Engineering Controls Audit Program Audit Report, Arcadis, 2/14/2014)

WGI found evidence of AULs. The DRC dated April 17, 2008 (provided in Appendix F) requires an
engineering control (cap) at the maintenance area and institutional controls (land use restrictions) on the
entire subject property. The search for ELs and AULs by the Environmental Professional (WGI) is
supplementary to the User's obligation to search for ELs and AULs and report any findings to the
Environmental Professional.
