Margate Community Redevelopment Agency

Façade Improvements for the
Margate Shopping Center (Ace Plaza)

Margate Shopping Center (ACE Plaza)

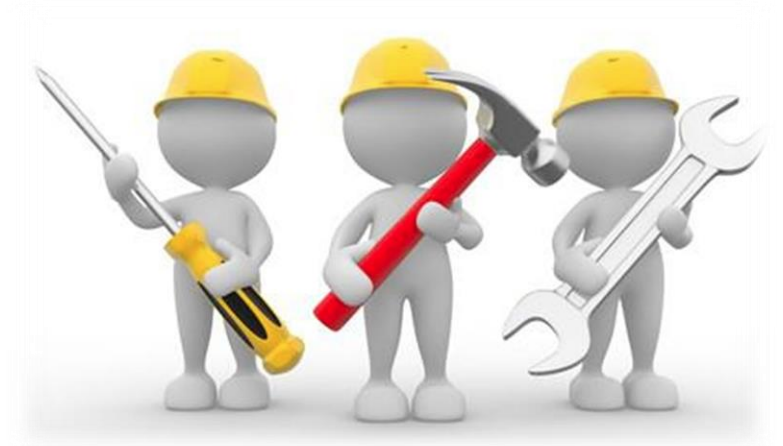
Building Repairs Needed

- * Bent soffits
- * Bent edging metal on mansard roof
- * Cracked concrete surfaces
- * Filling and prime paint window frames where needed

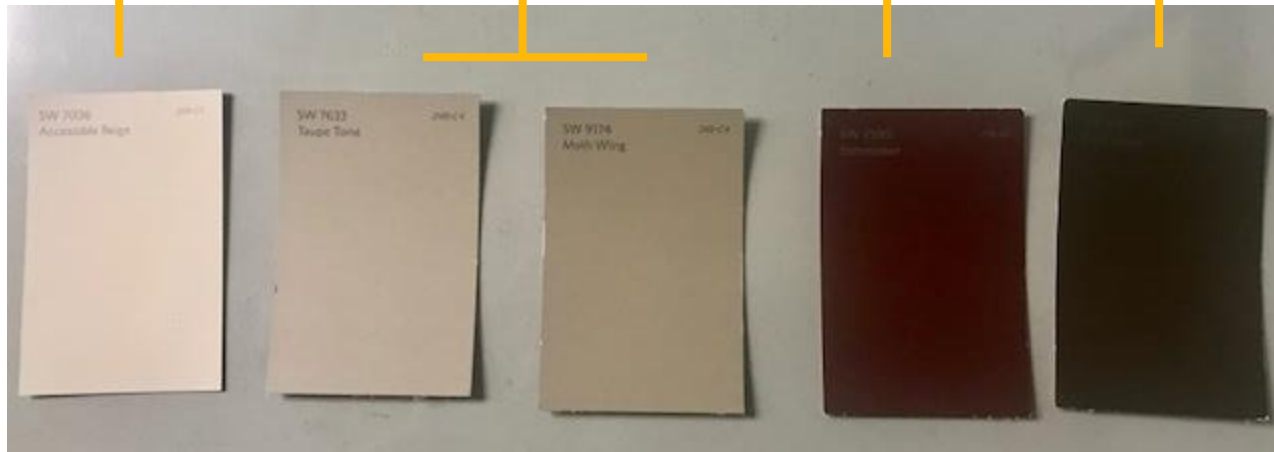
Proposed Color Palette

Walls

Mansard Roof
(2 Options)

Awnings

Accents, end
walls & walk
through

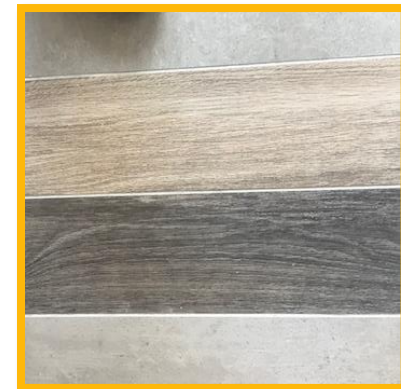
Proposed tile colors

- * Outdated painted brick to be covered with porcelain tile installed horizontally.
- * Light color on larger wall and dark color below windows.

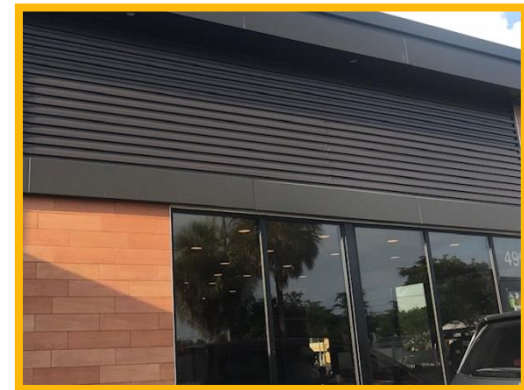
Proposed corrugated metal

- * Existing finish of brick, wood and stucco to be covered with corrugated metal in dark brown color (to coordinate with end accent walls).

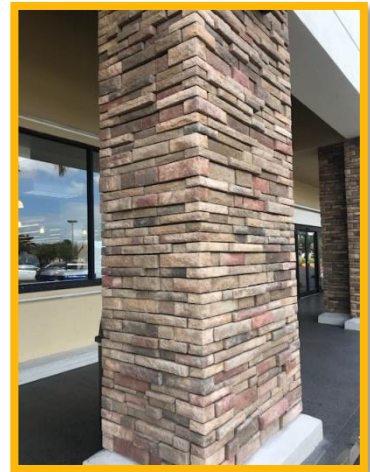
Proposed stacked stone

- * Proposed columns clad with stacked stone.
- * New columns created in certain locations for balance.
- * Size varies with existing size of column.

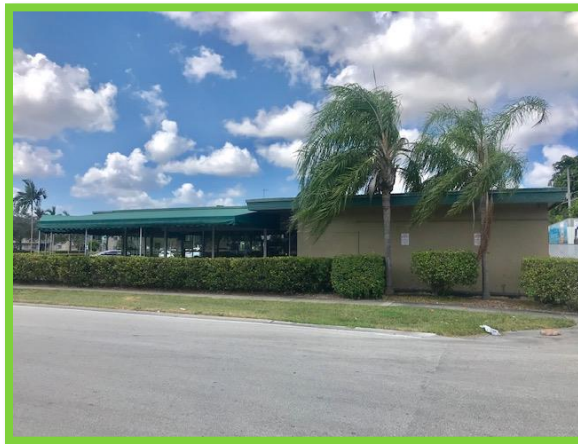
- * End walls to be painted in accent color.
- * Margate Shopping Center to remain (historical).

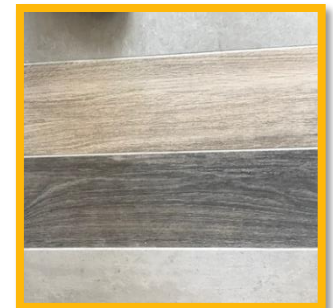
Proposed tile colors

- * Eliminate arches and clad faux brick with porcelain tile.
- * Existing lines inset on stucco walls above windows will be highlighted with accent color.

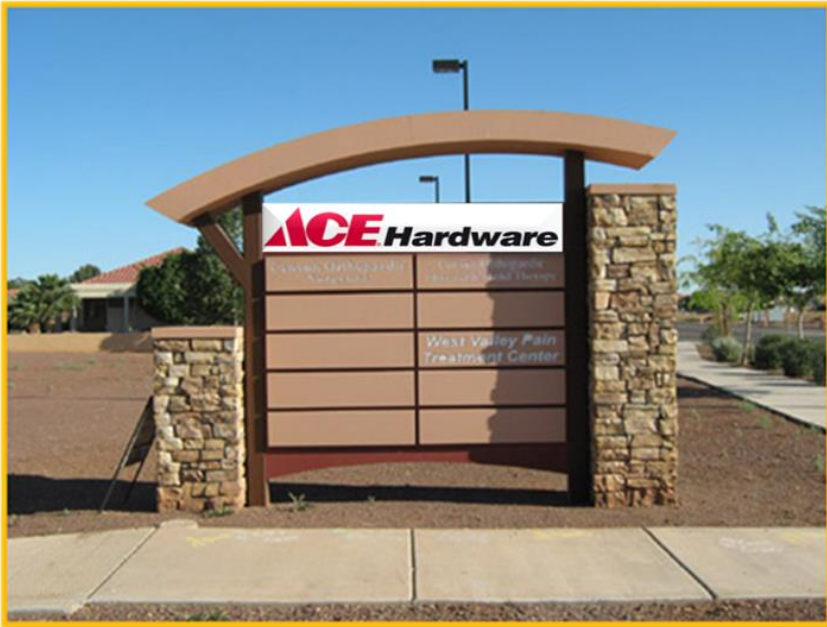
Sample Monument Signs

- * Recommend fabrication and installation of new shopping center sign to be visible from State Road 7.
- * Use same stone as shopping center columns and relate to new wayfinding design cues.
