# Walking Audit Report

## City of North Lauderdale and Margate

Southgate Boulevard from

SW 81<sup>st</sup> Avenue to SR 7/US 441

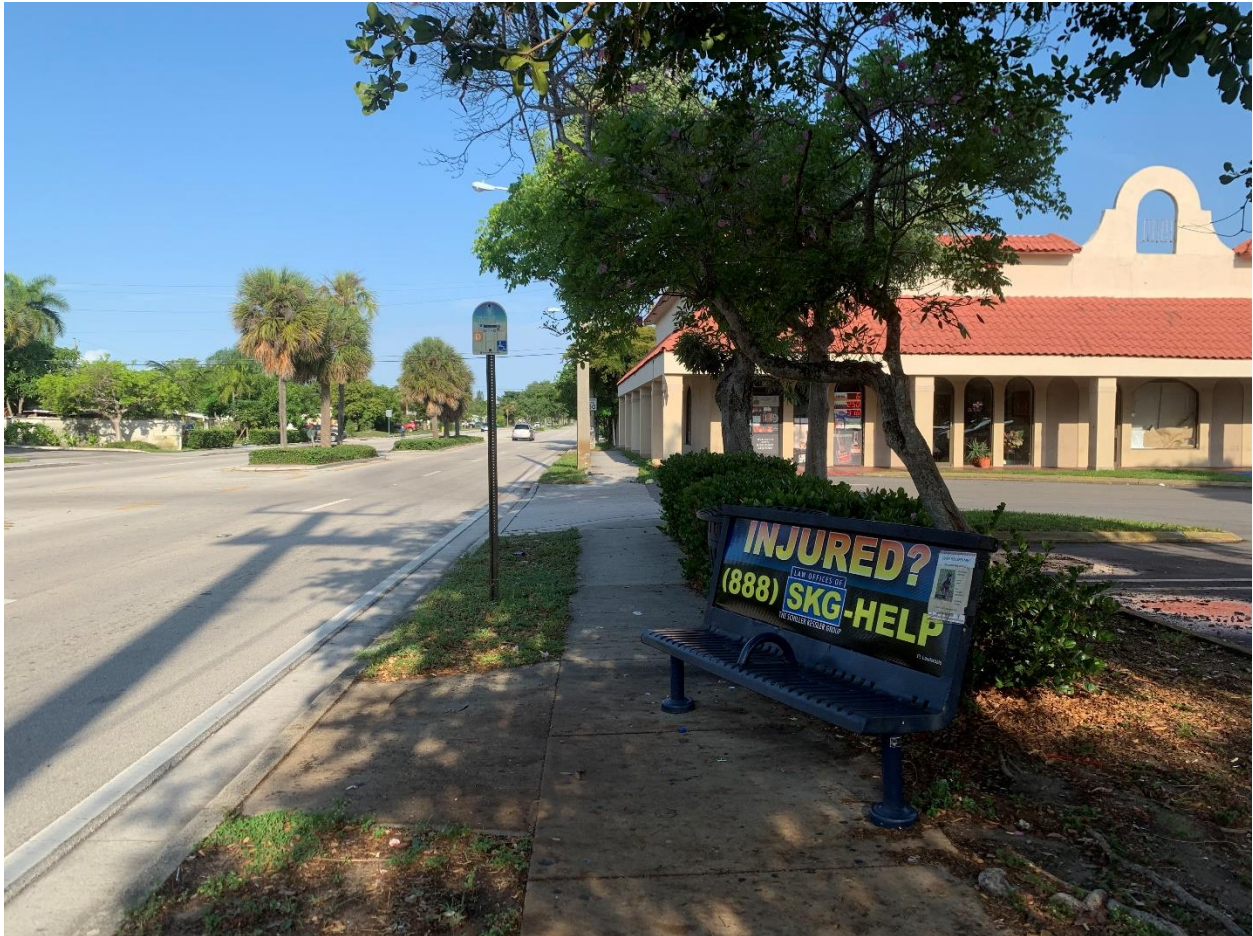
*Margate Inner-City Transit Route D bus stop with seating on Southgate Boulevard west of US-441/SR-7*

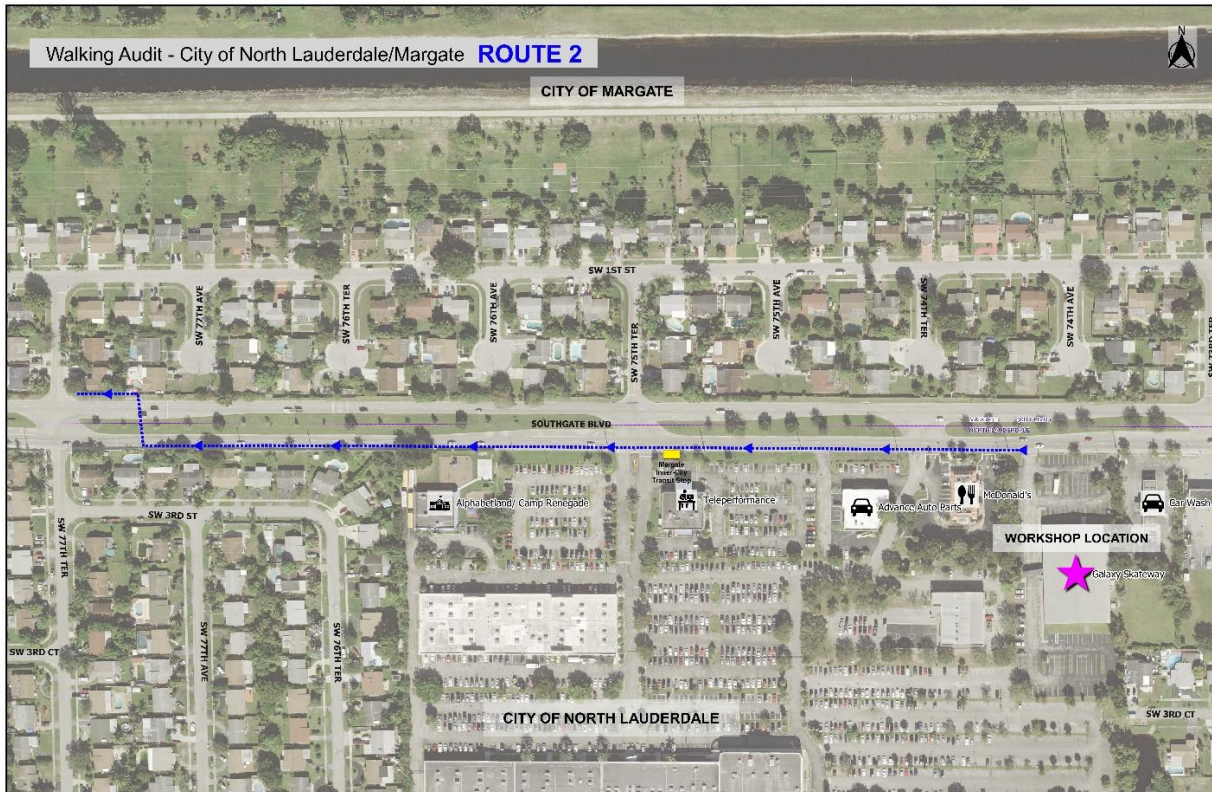
Figure 5. Walking Audit Route 2 – destinations

Shown in Figure 5 are the different destinations along Route 2. The northern side of Southgate Boulevard is heavily residential. The southern side of Southgate Boulevard includes an auto repair shop, child care facilities, and an office. Appendix A includes the aerial maps shown in its original size.

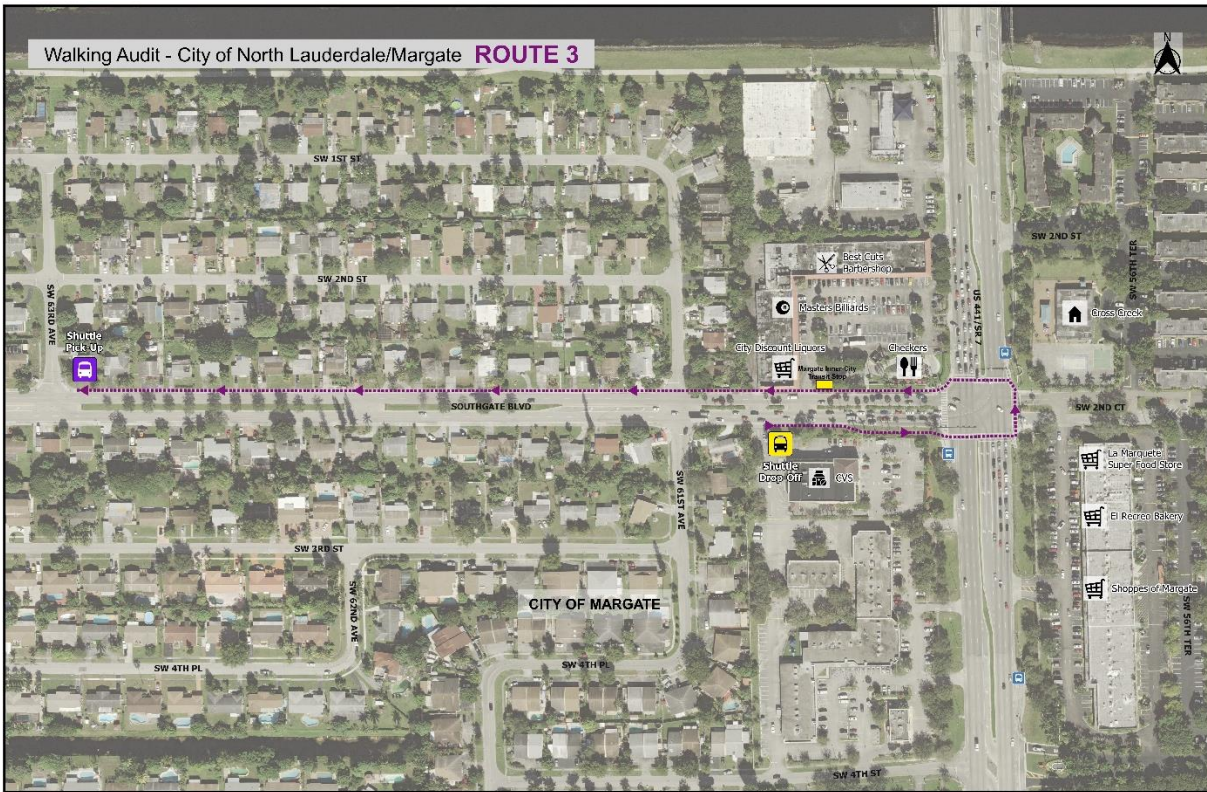
Figure 7. Walking Audit Route 3 – destinations

Shown in Figure 7 are the different destinations along Route 3. The northern side of Southgate Boulevard is heavily residential. The southern side of Southgate Boulevard includes an auto repair shop, child care facilities, and an office. Appendix A includes the aerial maps shown in its original size.

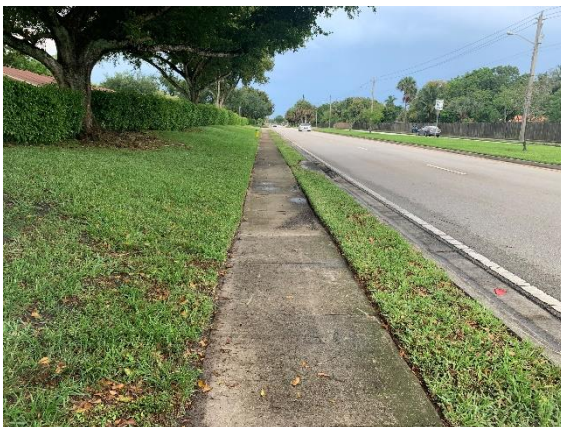
Sidewalk on the north side of Southgate Boulevard with a buffer between the sidewalk and curb, also known as a furnishing zone.

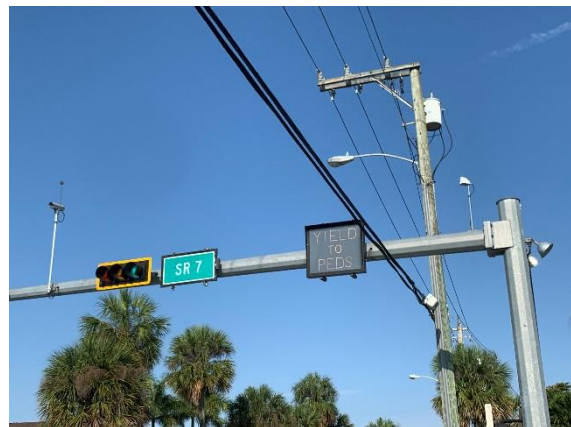
Variable message sign for NO TURN ON RED/YIELD TO PEDS on all four legs at the intersection of Southgate Boulevard and SR-7/US-441.

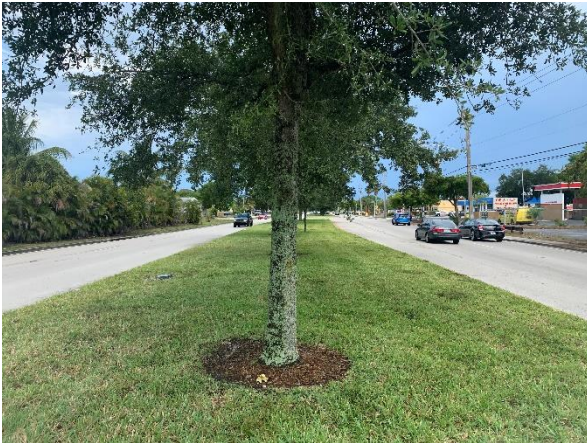
There is a 30- to 40-foot median dividing the east and westbound lanes of Southgate Boulevard, providing landscaping and beautification of the corridor.

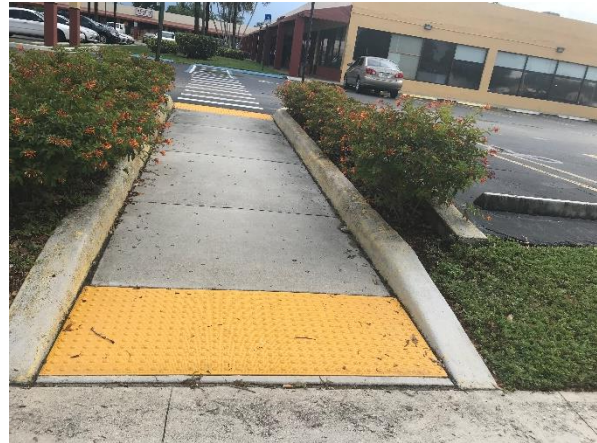
Several businesses along the corridor provide pedestrian access with ADA compliant detectable warnings and ramps. This access point leads to the Presidential Plaza shopping center.

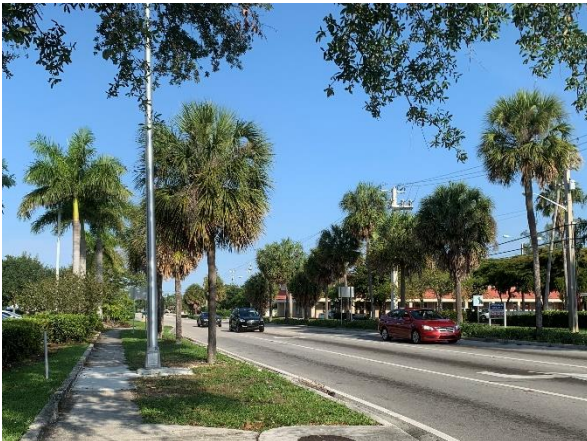
Along the south side of Southgate Boulevard near SR-7/US-441, there are some trees that provide shade.

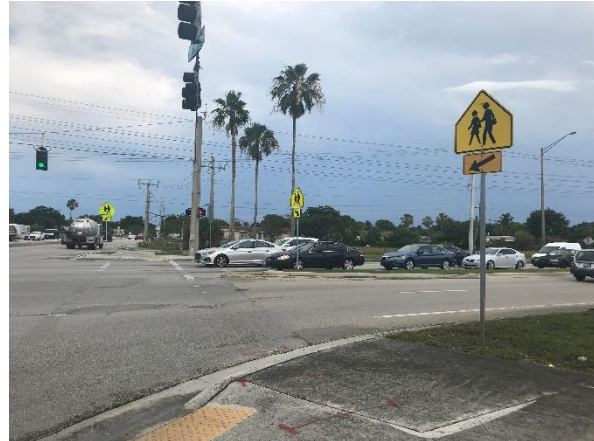
Pedestrian signage is present in most areas where pedestrians may cross vehicular traffic, including intersections and driveways.

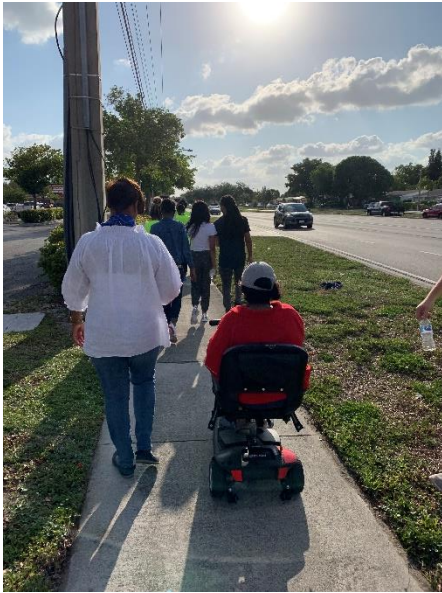
The sidewalk width is 5 feet.

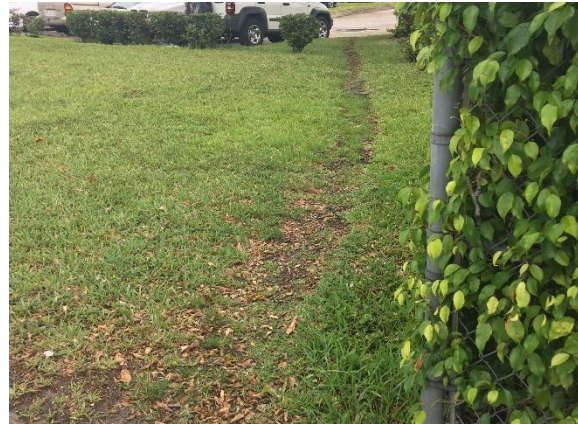
Desire path on the south side of Southgate Boulevard west of 75<sup>th</sup> Terrace showing pedestrian access point to shopping center. Provide a paved pedestrian access point at this location.

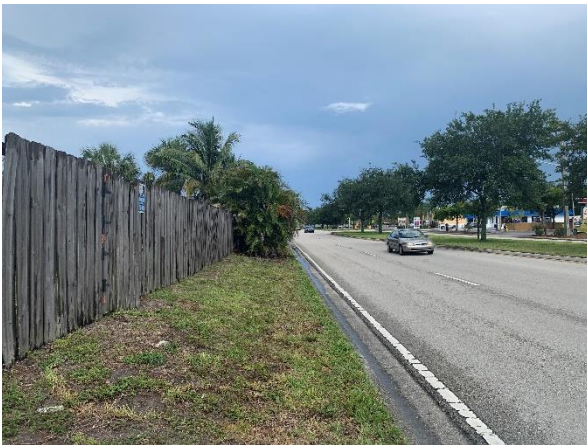
Lack of sidewalk facilities along the north side of the corridor from SW 79<sup>th</sup> Avenue to SW 69<sup>th</sup> Terrace.

Provide a continuous sidewalk with trees adjacent to facility to add shade.

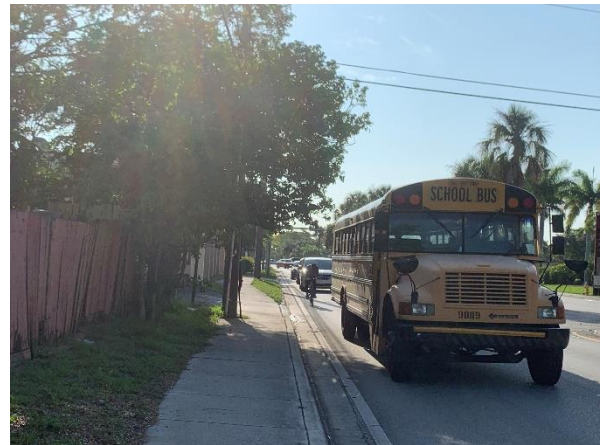
There is a lack of bicycle facilities throughout the corridor resulting in bicyclists riding in the travel lanes alongside motor vehicles.

Provide a green marked bicycle lane east of SW 65<sup>th</sup> Avenue.

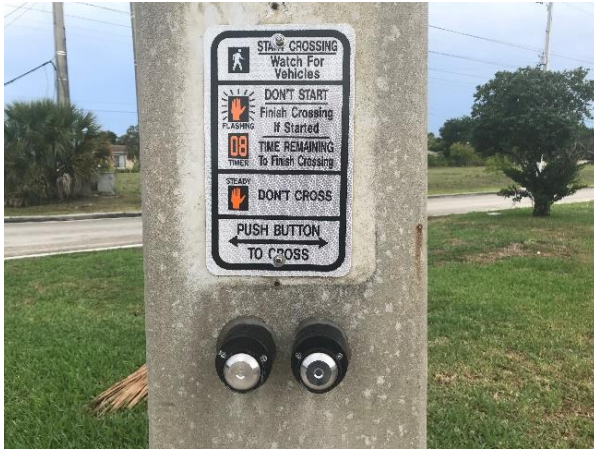
Pedestrian push buttons are not oriented toward desired crossing street and signage is not provided for each approach.

Upgrade the pedestrian push buttons and signage on Southgate Boulevard at the following signalized locations similar to the example above.

- SW 81<sup>st</sup> Avenue
- Mid-block crossing east of SW 77<sup>th</sup> Terrace
- Rock Island Road/SW 71<sup>st</sup> Avenue

- Upgrade the pedestrian push buttons and signage on Southgate Boulevard at the following signalized locations.
  - SW 81<sup>st</sup> Avenue
  - Mid-block crossing east of SW 77<sup>th</sup> Terrace

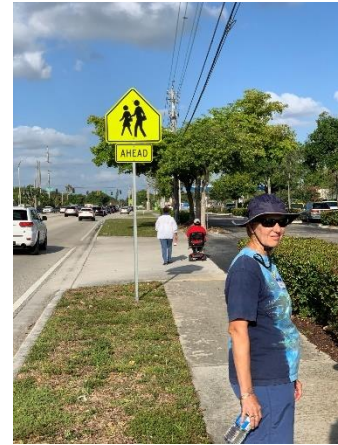
The driveway apron goes through the sidewalk/pedestrian crossing at the Presidential Plaza.

Provide sidewalks at the Presidential Plaza to allow a flat driveway crossing that is at least three feet wide with a side slope of less than 2%.

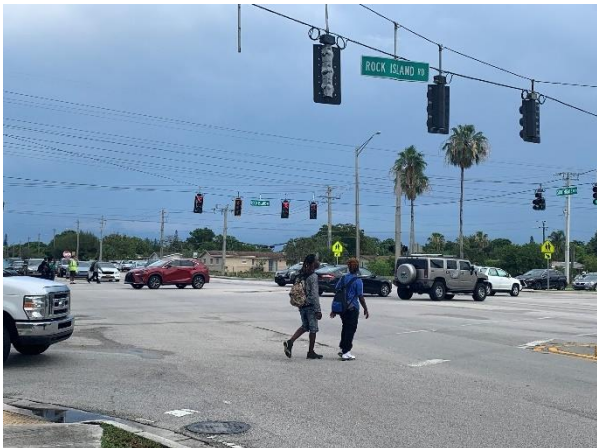
The marked crosswalk pavement markings at Southgate Boulevard and Rock Island Road/SW 71<sup>st</sup> Avenue is faded.

Provide special emphasis crosswalk markings at Southgate Boulevard and Rock Island Road/SW 71<sup>st</sup> Avenue.

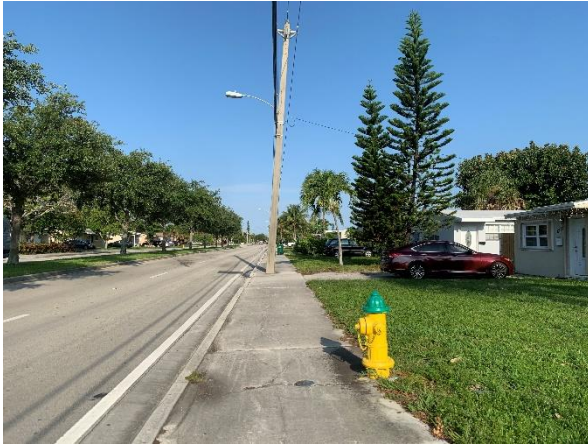
Street fixtures are within the sidewalk, which prevents a clear pedestrian zone.

Relocate fixtures from pedestrian zones or if unable, provide additional space to maintain ADA compliant width.

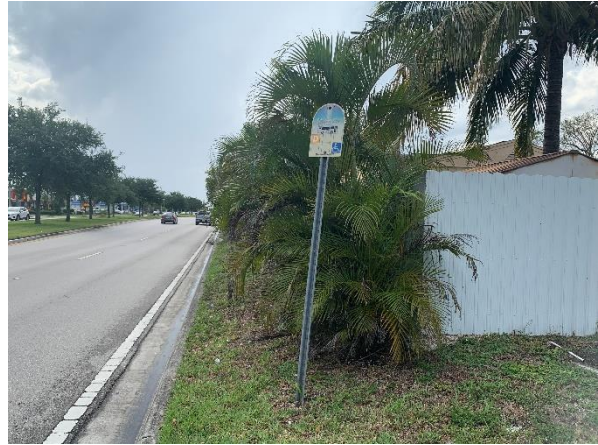
Route D stop located west of SW 73<sup>rd</sup> Terrace does not have proper bus stop amenities such as ADA landing pad/passenger waiting area, bench, shelter, trash receptacle, lighting & etc.

Provide a clear unobstructed 5'x8' landing pad and provide amenities such as bench, shelter, trash receptacle, bike racks, and a handrail at the Margate Inner-City Transit Route D stops.

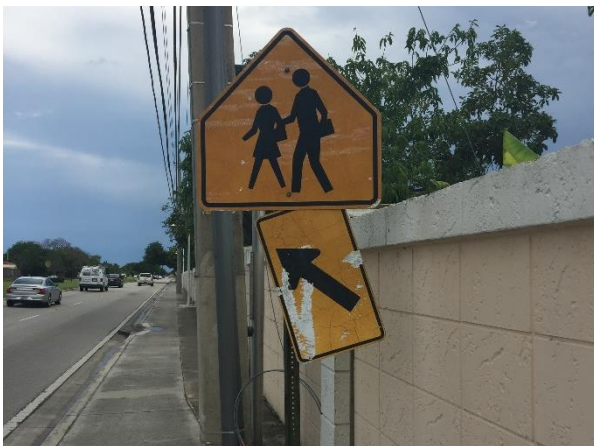
Pedestrian crossing signage damaged located at mid-block crossing along Southgate Boulevard east of SW 77<sup>th</sup> Terrace.

- Replace damaged pedestrian crossing signage located at mid-block crossing along Southgate Boulevard east of SW 77<sup>th</sup> Terrace.
- Maintain the landscape throughout the corridor to prevent blocking pedestrian space, improve visibility, and reduce blocking the view of pedestrian signs.

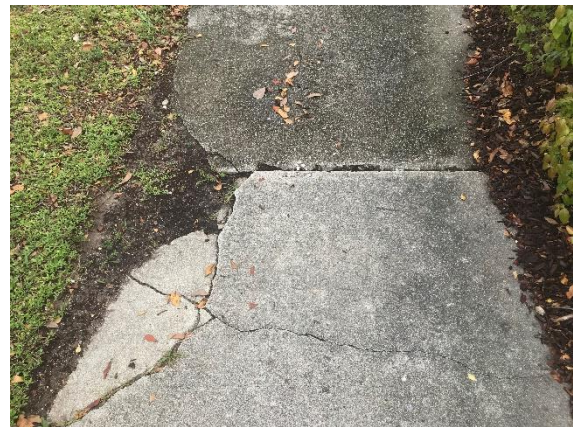
Sidewalk cracking which causes trip hazards.

Evaluate the condition of sidewalks intersecting driveways and sidewalk condition to ensure a cross slope of 1% (2% maximum) to meet ADA standards.

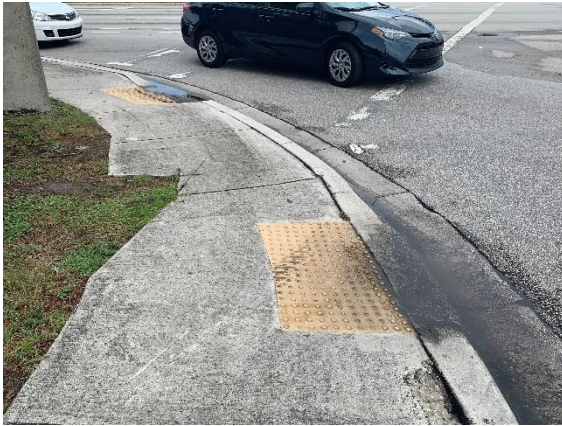
Drainage issues at the intersection of Southgate Boulevard and Rock Island Road/SW 71<sup>st</sup> Avenue which causes pooling of water at curb ramps.

- Evaluate the condition of sidewalks intersecting driveways and sidewalk condition to ensure a cross slope of 1% (2% maximum) to meet ADA standards.
- Insert a catch basin which includes an inlet, riser, and piping to prevent drainage issues.

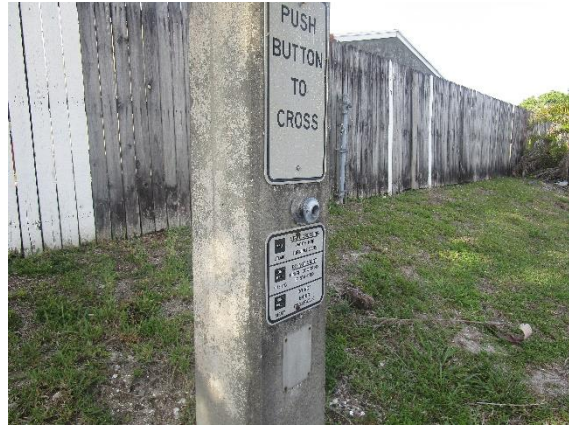
Outdated pedestrian pushbutton at mid-block crossing along Southgate Boulevard east of SW 77<sup>th</sup> Terrace.

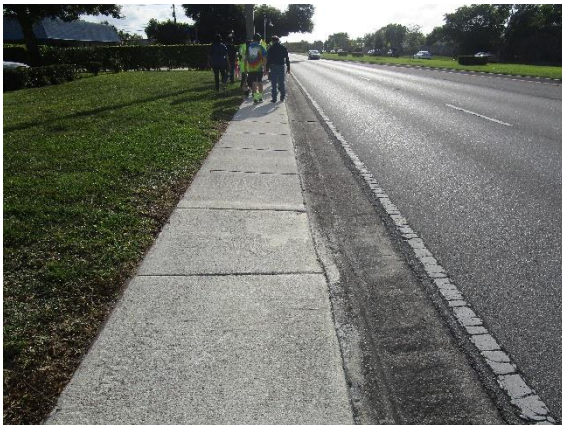
Curb cut for former driveway west of SW 75<sup>th</sup> Terrace is unnecessary and should be reconstructed.

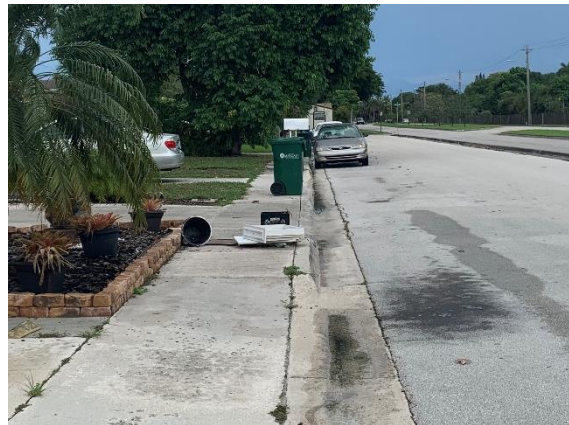
The sidewalk on the north side of Southgate Boulevard is adjacent to residential driveways and is used for trash pick-up.

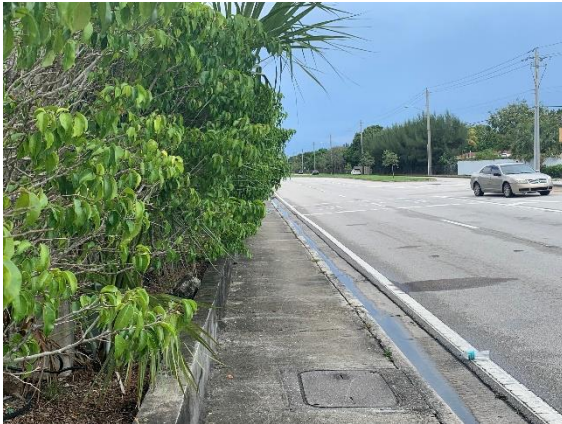
Overgrown trees endanger pedestrians and block the view of pedestrian signs.

Maintain the landscape throughout the corridor to prevent endangering pedestrians and blocking the view of pedestrian signs.

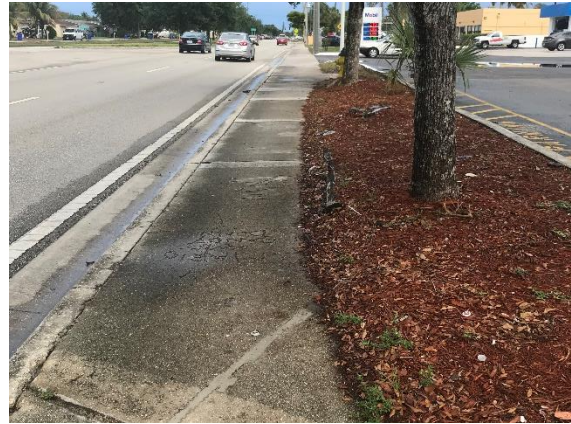
Unmaintained landscape encroaches the sidewalk facilities.
